**Tree Survey:** Trees at the Recreation Ground and to the east of the church.

**Client:** Brede Parish Council.

Date: November 2023

**DKS-FN/02F**

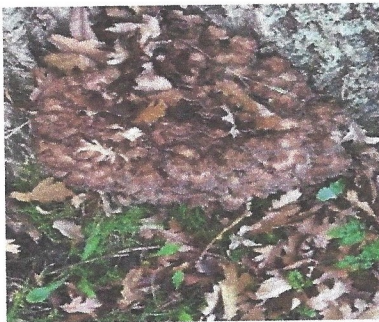
Tree	Species	Life Stage	Condition	Height & Dbh	Comments
T1	English Oak Old tag 0306	M	<p>Well balanced crown, starting to exhibit veteran features. Height to lowest part of canopy = 1.8m. Open unions, no tight forks.</p> <p>Crown spread: N 11.5 m      E 12 m S 10 m      W 8 m</p> <p>Good crown density and size of leafing. Previous management good – tree has responded well, all previous wounds have partially or totally occluded.</p> <p>Minor mechanical damage to NW side of main stem, with a cavity at ground level – localised. This is not unusual for a tree of this age. An old tear is evident in the top of the crown on ascending branch – mid crown which is only partially occluded.</p> <p>No exposed roots or signs of root plate lifting. Lateral scar on Eastern side at ground level to 2m. Deepest point on probing 200 mm – leads to a tight union – mitigated on far side with good compensatory growth. Some signs of hollowing associated with lateral cracking to Eastern buttresses but Northern and Southern buttresses are sound. Decay is therefore currently localised but needs monitoring.</p>

<p>2023 fungal activity.</p> <p>Dead wood in canopy continues and evidence of falling small stems.</p>	21 m 157 5 mm Dbh	<p>Footpath and road (4 m) to the South.</p> <p>Recommend annual inspection.</p> <p>Old fruiting bodies evident on the ground on first site inspection, but have been removed. Likely <i>Inonotus dryadeus</i>.</p> <p>Important amenity tree to the area.</p> <p>Recommend cyclical reduction plan, to maintain at current size – within five years carry out light sympathetic reduction to BS 3998. Provides good nesting and roosting habitat.</p> <p>2022 Elder has been removed allowing clear access around the base of the tree. <i>Grifola frondosa</i> observed in 2021 was not present, but could have been removed by landscapers. Ground has recovered well after demolition of the pavilion. Blackening (<i>Bulgaria inquinans</i>) (see index) within fature on eastern side of the main stem has worsened. It is and there is some new mechanical damage on the northern buttress. (see index).</p> <p>2023 The cracking and cavity on the eastern side of the main stem have widened, (cavity depth 35 cm) with hollowing sounds thereon. Fungal growth has got larger and stronger.</p> <p>Continue to monitor annually.</p>

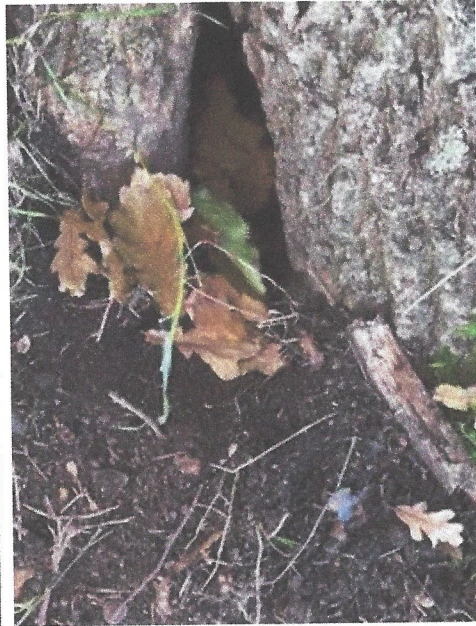
2023 Cavity on eastern side  
of the main stem.

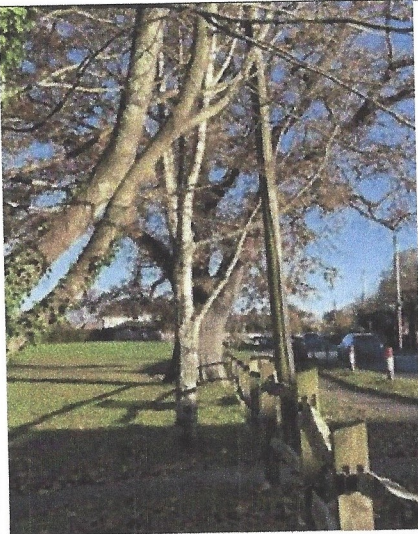
T2	Silver Birch	EM	<p>Tree exhibits exposed roots from W to E which are damaged and compacted.</p> <p>Drooping canopy may be drought stress and compaction.</p> <p>Deadwood present within crown. Tree shows a propensity to form tight unions although none are showing signs of bark inclusion at time of inspection.</p> <p>Base appears sound no sign of hollowing.</p> <p>Yellowing of leaves and crown becoming sparse indicate tree is under cultural stress.</p> <p>Root disturbance caused by new concrete path may have contributed to sparse canopy. Little nesting or roosting habitat value.</p>	<p>13.5 m</p> <p>Dbh 310 mm</p>	<p>Recommend light forking of ground to decompact soil within root zone- to 50 mm puncture points and move slightly to allow permeability of ground, do not lift or turn soil over (2019). <u>This has not been carried out 2020.</u></p> <p>2022 Improved ground conditions have benefitted the canopy of the tree.</p> <p>Recommend removing low value <i>Amelanchier</i> at base to release T2 (2029). <u>This work has been carried out 2022.</u></p> <p>Recommend annual inspection if retained. Recommend fell in the longer term if development plans go forward for new buildings.</p> <p>Proximity to Maple leaves this tree in a long term unsustainable relationship with its surroundings.</p>

<p>2023</p> <p>No real change - crown will rebalance itself now that the pavilion has been removed.</p>		
T3	Norway Maple	M	<p>Poorly formed tree with three major stems, all with poor unions.</p> <p>2022 Pavilion has been removed and the ground has recovered well .</p>	<p>15 m</p> <p>Dbh 305</p>	<p>This tree will eventually grow into failure. To retain the tree it is recommended that cyclical reductions are carried out.</p>

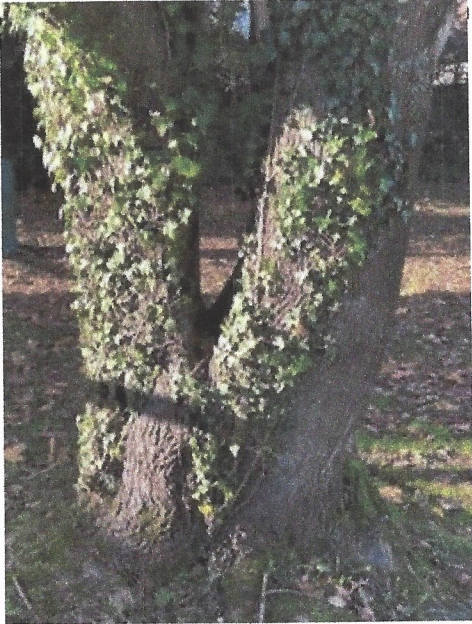
<p>Poor unions, with bark inclusion throughout the tree.</p> <p>Secondary thickening as tree grows and increase in lever arm stress on unions will eventually result in structural failure.</p> <p>Multiple tight unions with inclusion currently showing minimal signs or subsidence and stress.</p> <p>Low amenity value tree.</p> <p>Exposed roots associated exhibiting mechanical mower damage.</p> <p>Limited root area with concrete platform within 0.5 m. Aspect ratio on lower limbs is poor. Small amount of deadwood in mid-crown. Poor occlusion of old cuts with associated cavities on</p>	<p>365</p> <p>550 mm</p>	<p>2022 – if the pavilion has been removed is going to be replaced, felling and replanting would be a more viable option, especially if any new building would have foundations and would be in the same location as the demolished one.</p> <p>Monitor annually if retained.</p> <p>2023 Root damage continues with grass cutting blades set too low.</p>

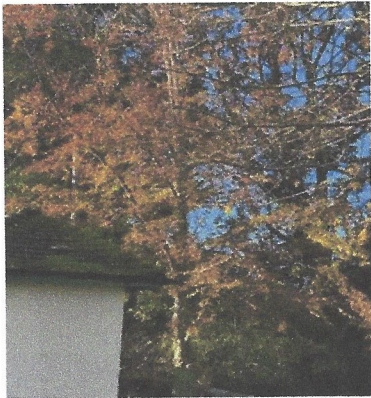
T4	Beech	SM	<p>2022 – now totally green foliage exhibited. Poorly situated tree, with bus stop to South, pavilion to North.</p> <p>Tree has some structural vulnerabilities with poor unions present within crown – principally Southern lateral at 4 m.</p> <p>Base sound.</p>

<p>2023</p>	<p>13 m</p> <p>Dbh 220 mm</p>	<p>Tree of poor form with low arboricultural value, consider removal and replacement. Tree has now fully reverted to green foliage</p> <p>2022 Foliage is resting on the roof of the bus stop and will damage tiles – recommend lifting canopy. Tips of canopy have died back. Root protection would be necessary in the event of a rebuild.</p> <p>Monitor annually if retained.</p> <p>2023 – The beech has benefitted from the additional light as a consequence of the removal of the pavilion and has flourished. Keep the crown lifted over the adjacent bus stop.</p>
T5	English Oak	M	<p>Tree is under stress having lost some root function. Tree assessment limited due to the Western neighbour boundary – Pea beach driveway to the west has created compaction of the roots. Heavy ivy cover has made assessment difficult in the past – now redressed to some extent.</p>

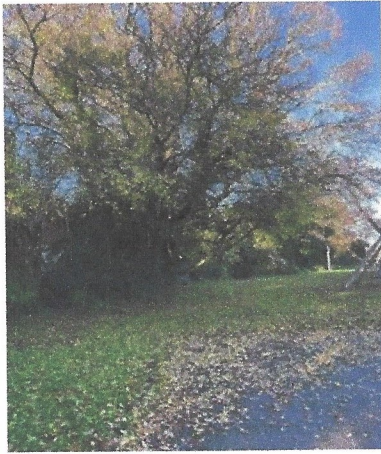
G1	<i>Prunus</i> and Damson	SM	<p>Presents as one crown. Crowns extend out (60%) to the East due to competing boundary hedge with neighbour. Good West lateral spread with no signs of root plate lifting.</p> <p>Historic level change in root growing area - ditch to West – roots well adapted.</p>

<p>2023</p>	<p>7- 8 m</p> <p>Dbh 300 mm &amp; 250 mm</p>	<p>Basketball court area to South-east within 5 m.</p> <p>Recommend annual inspection.</p> <p>2022 – area has been cut back, still retaining good wildlife areas and roosting abilities.</p> <p>2023 - this group has extended out to the east, and is in danger of encroaching over the adjacent basket ball area - recommendation to cut back before it becomes a larger job.</p>
----	--------------------------	----	--	--	---

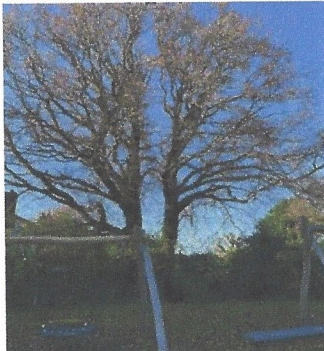
T7	English oak	M	<p>Two bay swings and nest swing to the east. Heavy Ivy cover preventing full assessment. Co-dominant stems.</p> <p>Bifurcates at 1.5 m – union is currently sound on both sides.</p> <p>Impossible to access Western side of the main stem- panel fence to rear of main stem.</p> <p>Crown spread to east = 10m No signs of veteran features.</p> <p>Canopy touches cross bar of nest swing. No lean.</p> <p>No cracking observed.</p> <p>Small amount of compaction near base due to path.</p>	<p>19 m</p> <p>Dbh 1500 mm Est</p>	<p>Ivy has been severed</p> <p>Ascertain ownership of tree.</p> <p>Recommend annual inspection</p> <p>2022 laterals leaning towards cross bars have been lifted as suggested.</p> <p>2023</p>

<p>Low splitting point - consideration could be given to cable bracing the two main stems - photo above demonstrates the clear division of the stems which are more vulnerable to splitting away from each other in high winds.</p>

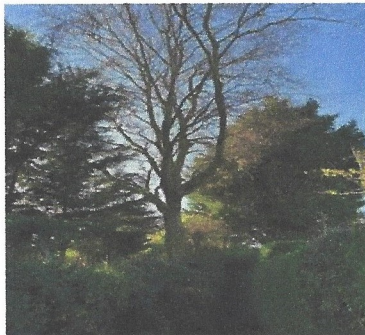
T9	Hornbeam	M	<p>Located by rear garden gate to neighbouring property.  Root damage observed due to compaction on pathway line.  Main stem is based on bank – very active rabbit burrowing in area could weaken stability.  Ivy has been severed.  Location prohibits full assessment.  Target area would be garden to North-west.  2022 – spread of crown to the north east – imbalanced crown.</p>

<p>2023</p>	<p>15.2 m</p> <p>Dbh 500 mm</p>	<p><b>Ascertain ownership.</b>  Fencing on Southern side of main stem – chicken wire absorbing into the tree.</p> <p>Recommend re-siting the fence and removing from stem without damaging the tree. 2022 Obviously this is dependant on ownership. Ivy has died and coming away from the main stem. Pulling it away would assist in enabling a closer inspection.</p> <p>2023 - no change.</p>
----	----------	---	---	---------------------------------	---

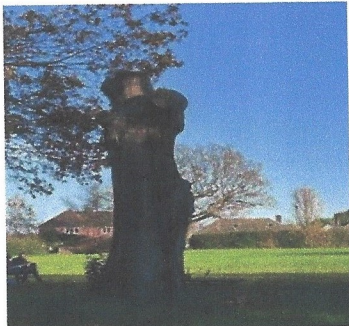
T10	English oak				2022 – removed.
T11	English oak	V	<p>Monolith Oak Excellent habitat.</p>

<p>2023</p>		<p>Create narrow pathway to rear of stem to assess basal condition - currently inaccessible.</p> <p>2022 – access to all sides is now clear – hollowing at base on eastern side - dig out to examine depth of hollowing. Hazel stem has established itself.</p> <p>2023 – no change – no significant deterioration</p>

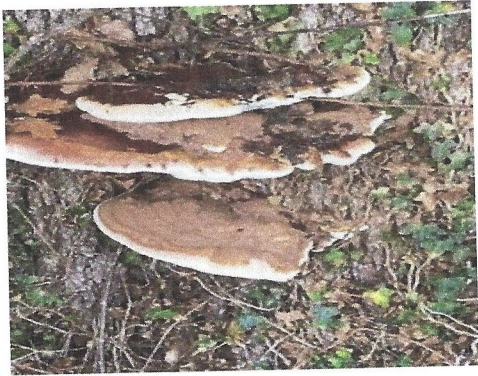
T12	English oak	M  Not Yet veteran	<p>Stands on Western boundary line of recreation ground.</p> <p><i>Ganoderma</i> spp. present x 2 on eastern side of main stem.</p> <p>Hollowing evident on South-eastern side – currently very localised – probe extent 200 mm + representing small narrow wedge of decay.</p> <p>Heavy Ivy cover within canopy prevents full assessment.</p> <p>Root morphology appears good despite bank and ditch.</p> <p>Deadwood in the lower canopy.</p> <p>Staining observed on major lateral to north at about 6 m.</p> <p>2022 – fungal bodies observed below:</p> <p>2023 – fungal bodies have extended on the eastern and western sides of the main stem. Ownership is still not established as far as the authors of the report area aware. There is a damaged cherry in the garden of the adjacent property which looks as though it might have been hit by a falling limb. Much deadwood in the area on the ground around play equipment. Recommend asking neighbour to share cost of removal of major deadwood.</p>	<p>22 m</p> <p>Dbh 1260 Est</p>	<p><b>Ascertain ownership</b></p> <p>2022 - Ivy has been severed and access to main stem established around base of the tree. to allow for full visual tree assessment and to allow inner crown leafing.</p> <p>Large bracket fungus on western and eastern sides of the main stem observed</p> <p>- <i>Ganoderma</i> spp - 3 now on eastern side and one on western side that appears well established and unobserved until now.</p> <p>Annual inspection.</p> <p>Limbs have been sympathetically lifted over gym equipment 2022</p>

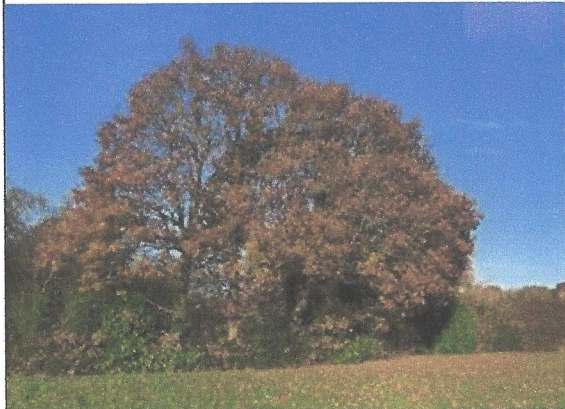
T13	Sessile oaks x 3	M	<p>Row of three Sessile oaks on Northern side of the recreation ground. To the North there is a 2m bank of and then a drop to a pond. No recent signs of root disturbance in the area.</p> <p>Heavy Ivy cover on all three oaks.</p> <p>Oaks one and two are co-dominant. Oak 1. bifurcates at 3 m – union is tight on the Northern stem but sound and sheltered location so unlikely to snap out. Oak 2 splits at 2 m with a tight union. Oak 3. Has a partially failed lateral to the Southern side at 3m – minimal lever arm - no need for action.</p> <p>Chicken wire absorbing into Northern side of Oak 3.</p>	<p>13 m</p> <p>Dbh</p> <p>380 mm 400 mm 500 mm</p>	<p>Monitor annually</p> <p>Important to retain screen to neighbouring pond as a safety deterrent to the pond.</p> <p>2022 – no change. No action necessary. 2023 – no change – no action necessary.</p>

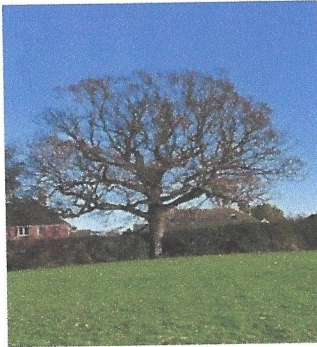
<p>2023</p>
T14	English oak	M	<p>Tree located on the Eastern boundary. Thick mixed hedge to rear and sides</p> <p>In conflict with chain link and wooden fence to the East.</p> <p>New row of Leylandii planting within garden on eastern boundary likely to have impacted on roots.</p>	<p>17 m</p> <p>Dbh 800 – 900 mm Est.</p>	<p>2022 – ivy growth has been severed but still well established in the crown of the tree. Laterals to north and south remain heavy – ownership appears to be with the Parish Council. Heavy acorn fall after dry summer.</p>

<p>First significant branch 2m in Northern and Southern directions.</p> <p>Branch subsidence on Second northern lateral at 5 m observed, indicative of torsional stress. .</p> <p>Target area would be neighbour's fence – decay may be present in that lateral.</p> <p>Heavy Ivy cover prevents full inspection. Crown is sparse indicating the tree is stressed, possibly due to root disturbance.</p> <p>No exposed roots.</p> <p>Foliage is discoloured - normally associated with poor root function and nutrient deficiency..</p> <p>Small but insignificant amount of deadwood in canopy.</p>		<p>Inspect annually</p> <p>Keep a photographic record to track crown condition.</p> <p>2023 – no change</p>
