Client: Parish Clerk: Ms T Dixon
Brede Parish Council

Site Address:
Brede Recreation Ground,
Udimore Road,
East Sussex,
TN31 6DG

Ref: SC/BPC/2/10/2024

TREE ASSESSMENT

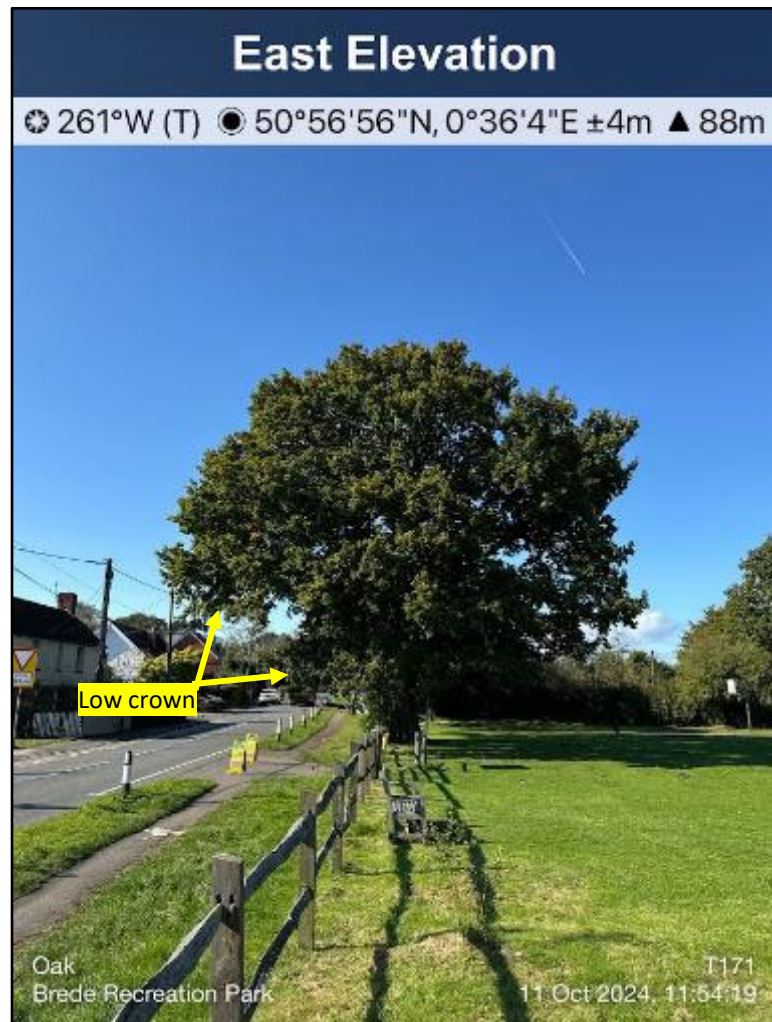
P.01

Ref.	Species	Target Information	Measurements	Structure	Survey Notes	Condition	Risk Category	Inspected	Inspect Period	Recommendations	what3words	Photo	Photo
T171	Pedunculate oak (<i>Quercus robur</i>)	Owned by local council. Parkland tree. Roadside tree. Tree in fence line. Target # - footpath. Target # - overhead wires. Target # - playground. Target # - road/stationary traffic. Target # - bus stop	Height (m): 23 Crown Radius (m): 12 DBH (cm): 168 Life Stage: Mature	Tree	The tree has a low crown that overhangs the public footpath and road. There is moderate deadwood throughout the crown, epicormic growth, and a subsiding north-facing branch. On the east side there are several small, deep cavities at ground level with an open crack and decay extending from one cavity up through a union to approximately 6m high, with no wound wood response and remnants of old fungal fruiting bodies inside. There appears to be another crack and dysfunction forming on the south side, with altered bark extending from the union down into the basal area. The stem is fluted with remnants of old fungal fruiting bodies that could not be identified due to their poor condition. I could fully insert my 77cm probe with a push into the cavities in the basal area on the east side of the stem; I believe the decay is extensive. If so, with the weight and size of the crown above, the crack on the east side and what looks like a second crack on the south side increases the likelihood of the tree splitting apart.	Fair	High:	07-Oct-2024	6 Months	Risk management: Further investigate the extent of decay with sonic tomography. Justification: This will help manage the tree, determine the extent of the decay, and decide what work is needed. Clearing access around the tree's stem, including a section of fencing, is essential for the sonic tomography equipment. Timescale: 07-Oct-2024 (Urgent)	///grumble.h atter.earlobes

T171- Oak

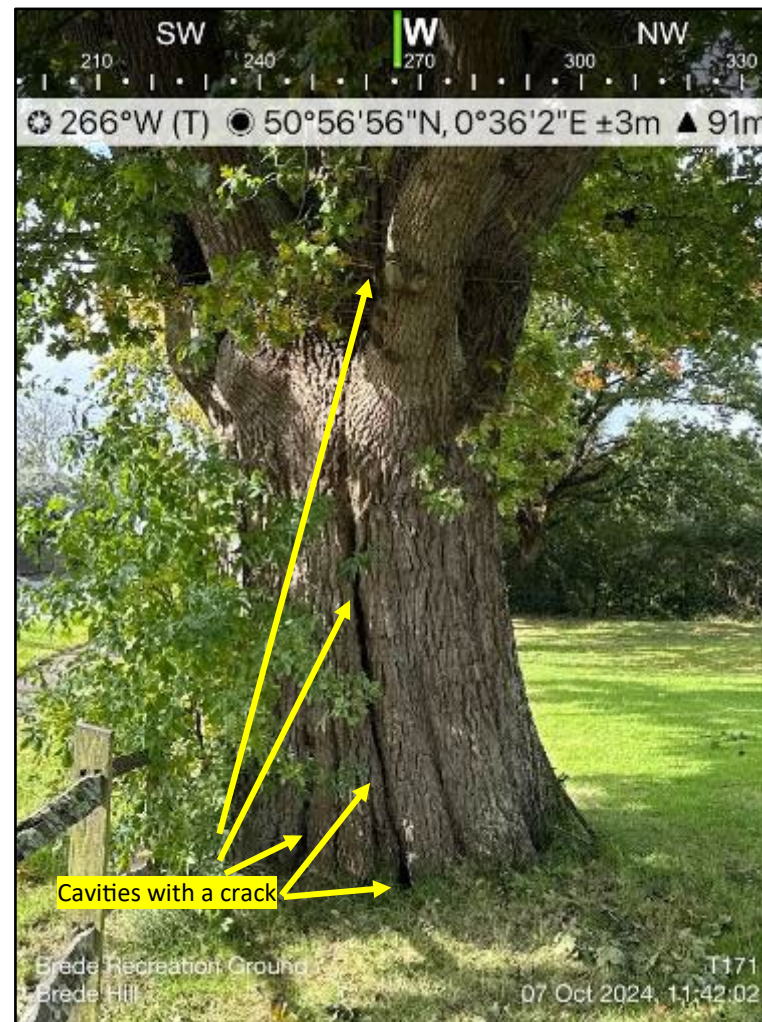
P.02

Several small, deep cavities and a sizable, elongated crack with old fungal fruiting bodies.

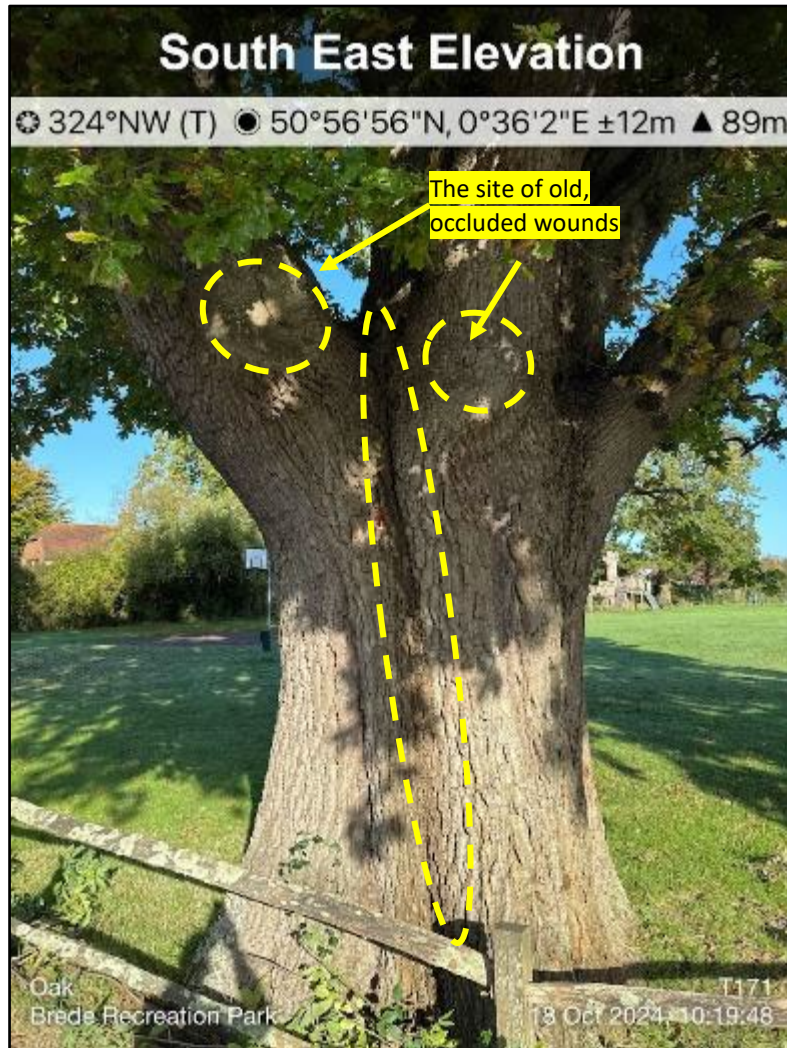
P.05

Start of another crack on the south side - yellow dash highlight

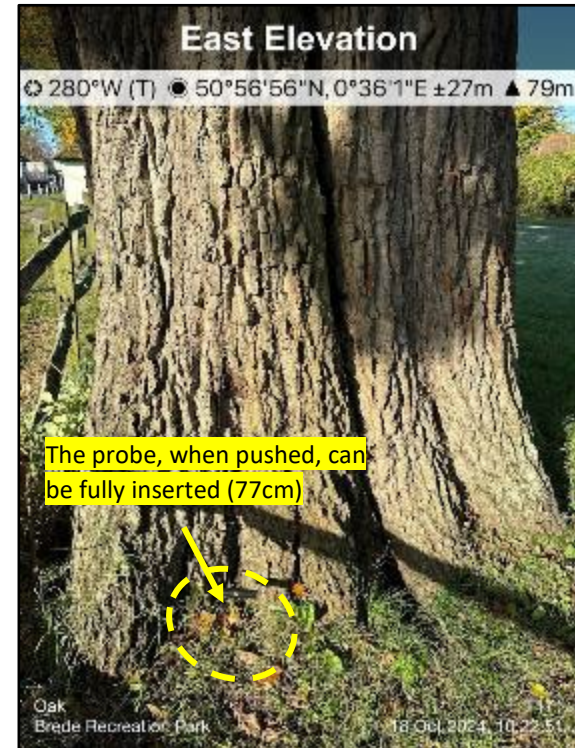
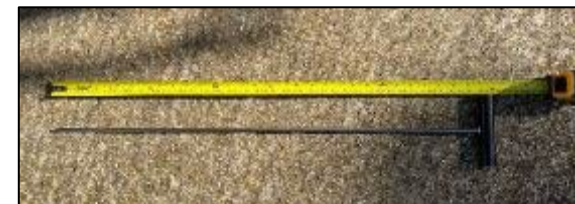
P.06

One of several cavities around the stem – yellow dash highlight
Probe length is 77cm

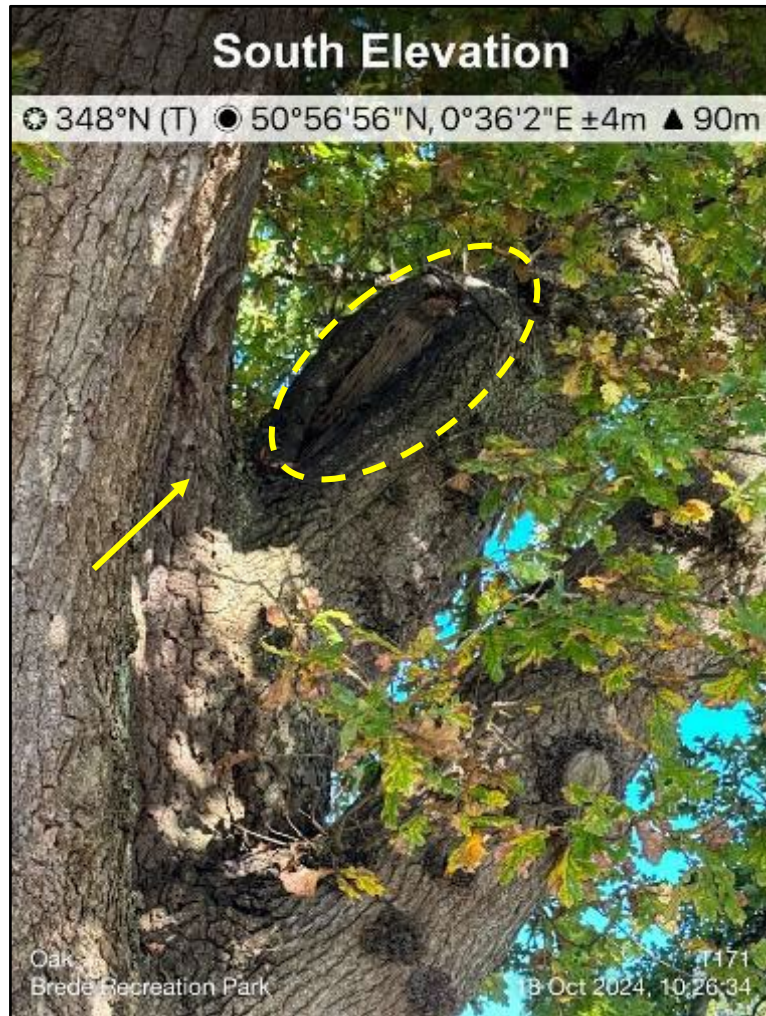
P.07

A sizeable wound next to the crack and branch attachment - yellow dash highlight

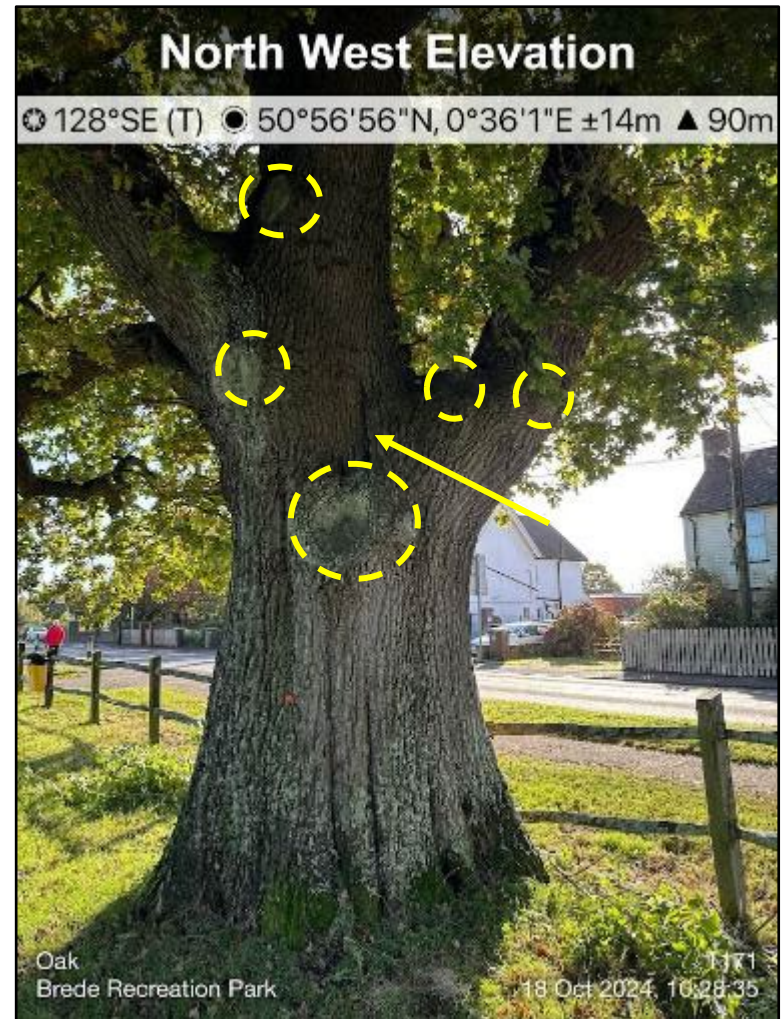
P.08

The sites of occluded wounds and a crack in the bark (yellow arrow)

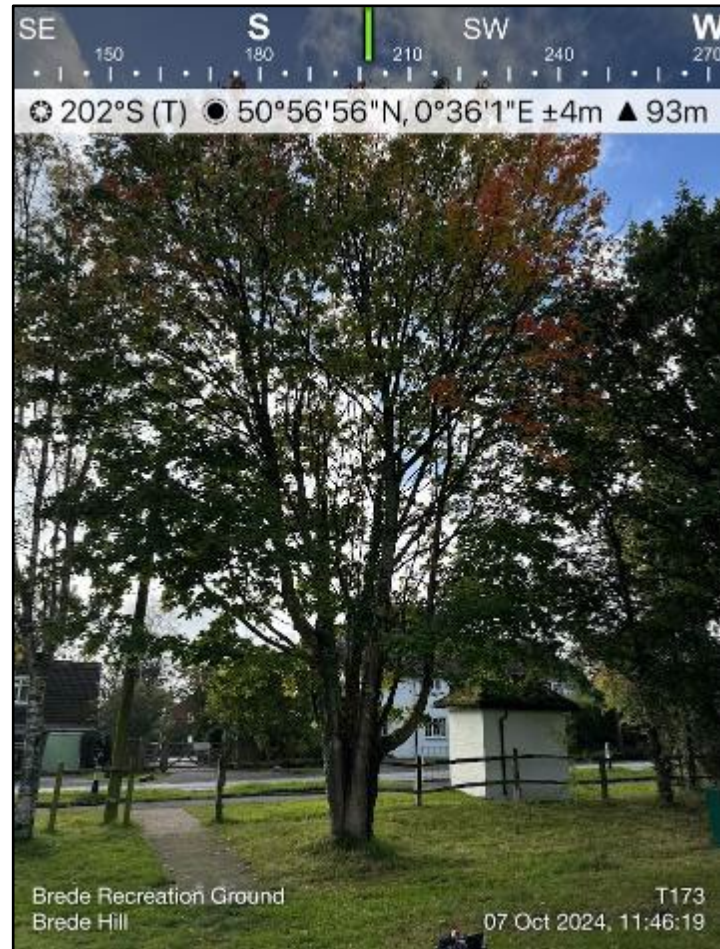
P.09

T173 – Norway maple with weak unions

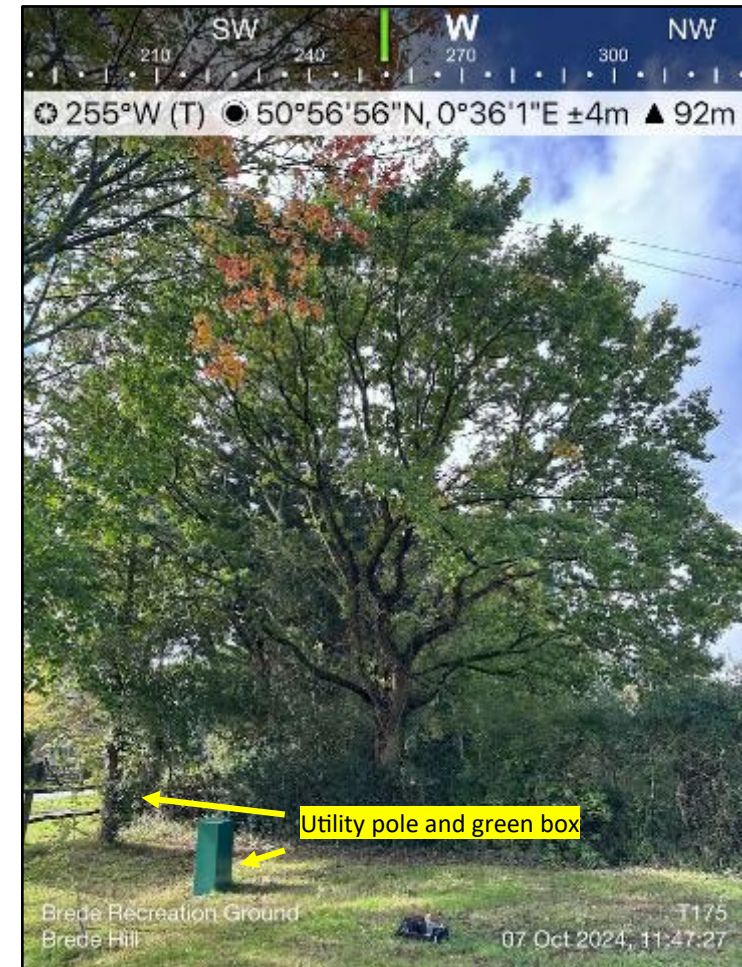
P.10

T175	Pedunculate oak (<i>Quercus robur</i>)	Owned by local council. Parkland tree. Tree in fence line. Tree in hedge. Target # - dwelling. Target # - overhead wires.	Height (m): 17 Crown Radius (m): 95 DBH (cm): N/A Life Stage: Mature	Tree	The tree is located in a hedge bordering the neighbouring property. Due to the hedging and lack of access to the neighbouring property, I observed the crown from the recreation ground. The stem is leaning 22° east, with moderate deadwood in the crown.	Fair	Moderate:	07-Oct-2024	1 Year	Risk management: Clear an access route to the tree and the hedging around its stem. This will aid future inspections. Remove deadwood 30mm Ø and greater. Prune 1.5m clear of the utility pole. Monitor the lean angle for possible movement. Reduce the height of the neighbouring holly tree to the south to 1.5m high. Justification - management of the tree Timescale: 07-Apr-2025 (6 Months)	///swims.fuss y.chiefs

T175 - Oak

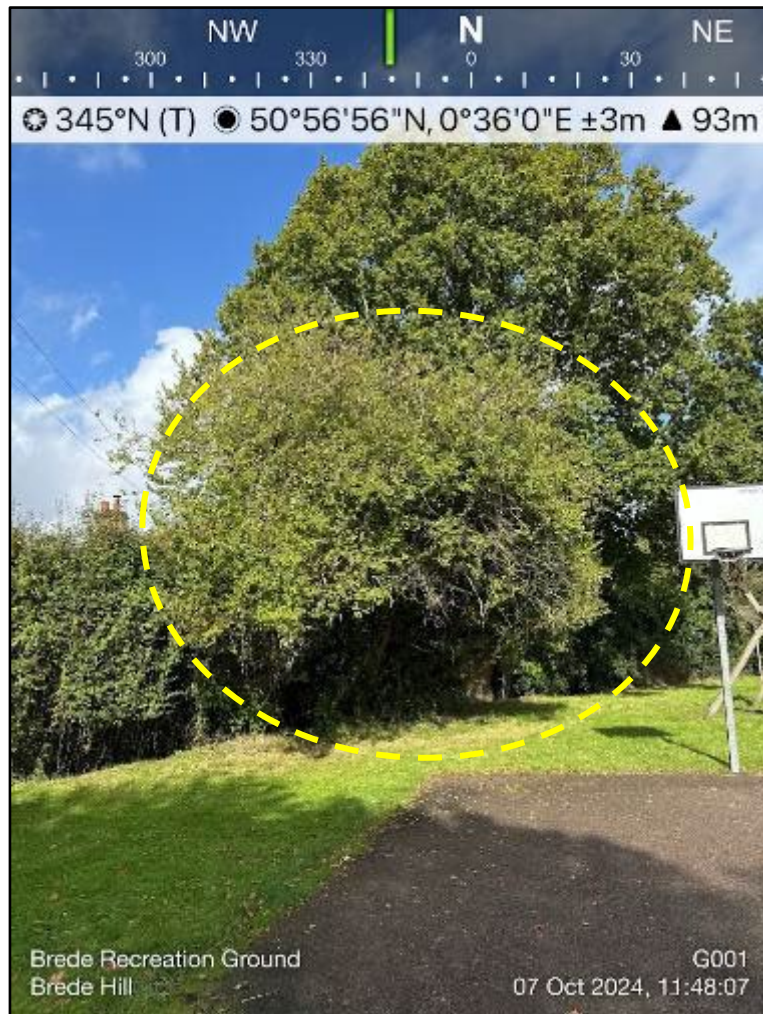
P.11

Ref.	Species	Target Information	Measurements	Structure	Survey Notes	Condition	Risk Category	Inspected	Inspect Period	Recommendations	what3words	Photo	Photo
G001	Mixed species x5 (Mixed species)	Owned by local council. Parkland tree. Tree in hedge. Target # - overhead wires. Target # - playground. Target # - dwelling.	Height (m): 12 Crown Radius (m): 7 DBH (cm): N/A Trees: 5 Life Stage: Semi Mature	Group	A group of ivy-clad mixed-species trees whose crowns overhang the playground and are amongst dense vegetation. Due to the ivy and vegetation, I could not inspect their stems and rooting environment, so I observed them from the recreation ground. Several branches are in contact with the overhead cables.	Not Recorded	Moderate:	07-Oct-2024	1 Year	Risk management: Clear an access route to the trees and the vegetation around their stems. Sever the ivy at the bases and remove a section. The ivy may be hiding possible defects. This will aid future inspections. Option1: Crown lift the east-facing branches from the playground by 3m and prune 1.5m clear of the overhead cables. Option 2: Top the tree 2.5m from ground level and crown-lift the east-facing branches 2.5m. This will remove the hazards. Justification: Tree management. Timescale: 07-Apr-2025 (6 Months)	///cyber.quietly.tribune

G001 – Mixed species

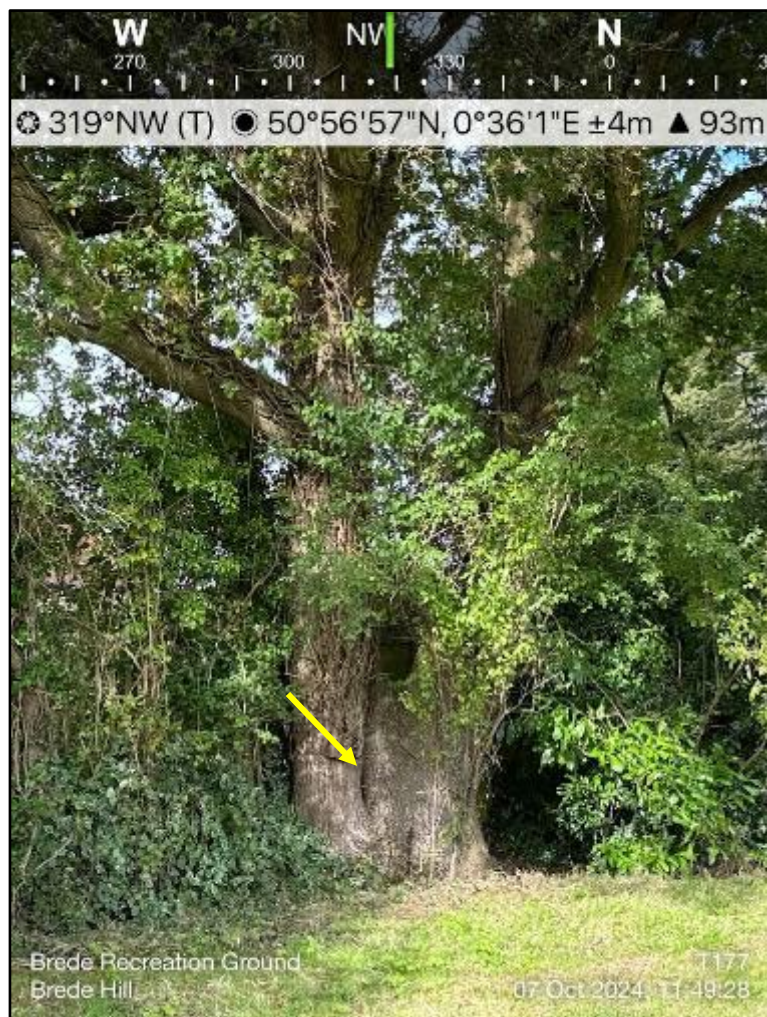
P.13

The tree has a tight, weak union (yellow arrow)

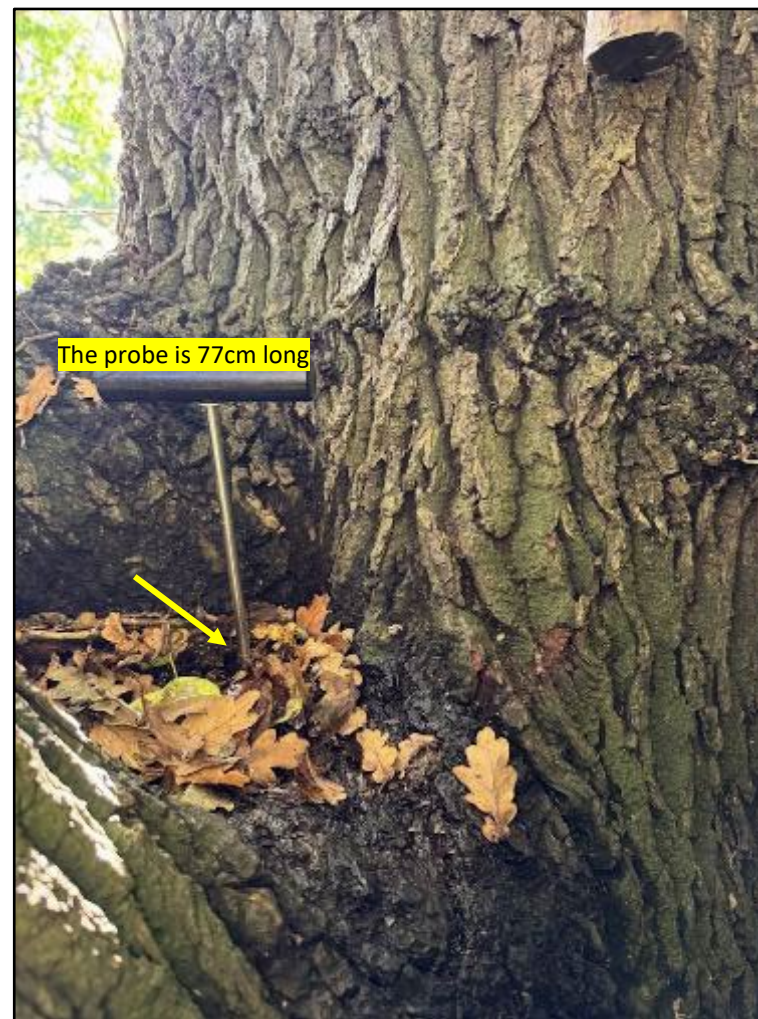
P.14

T177	Pedunculate oak (<i>Quercus robur</i>)	Owned by local council. Parkland tree. Tree in fence line. Tree in hedge. Target # - dwelling. Target # - overhead wires. Target # - play equipment Target # - seating.	Height (m): 25 Crown Radius (m): 13 DBH (cm): 150 Stems: 2 Life Stage: Mature	Tree	A large bifurcated tree is on the fence line next to the neighbouring dwelling, where part of the crown overhangs. It has major and moderate deadwood throughout. The stems show signs of parting/failing. I could insert my probe 58cm between the stems at the union in the basal area. No cracks were visible during the inspection, but the tree had a swelling on the west side of the stem, where I inserted my probe. This is reaction wood. The tree has recognised a weakness and is trying to strengthen the area. The size and weight of the crown increase leverage and high biomechanical stress loads in the union. The fence and vegetation limited access to this side of the stem. Due to the lack of access, I observed the crown from the recreation ground.	Not Recorded	Moderate:	07-Oct-2024	1 Year	Risk management: Crown reduce the whole tree by 3-4m and deadwood by 30mm Ø and greater. Insert an 8-tonne cobra brace 2/3rds of the height of the tree. This will help reduce the total failure of the stems if they fail and split apart. Justification: Crown reduction will alleviate biomechanical stresses, leverage, and wind sail. Management of the tree. Note: The bracing will need inspecting annually and an aerial inspection every five years. Timescale: 07-Apr-2025 (6 Months)	///jousting.tri ps.atoms

T177 – A bifurcated oak tree

The stems are separating, and the probe is inserted 58 cm between them.

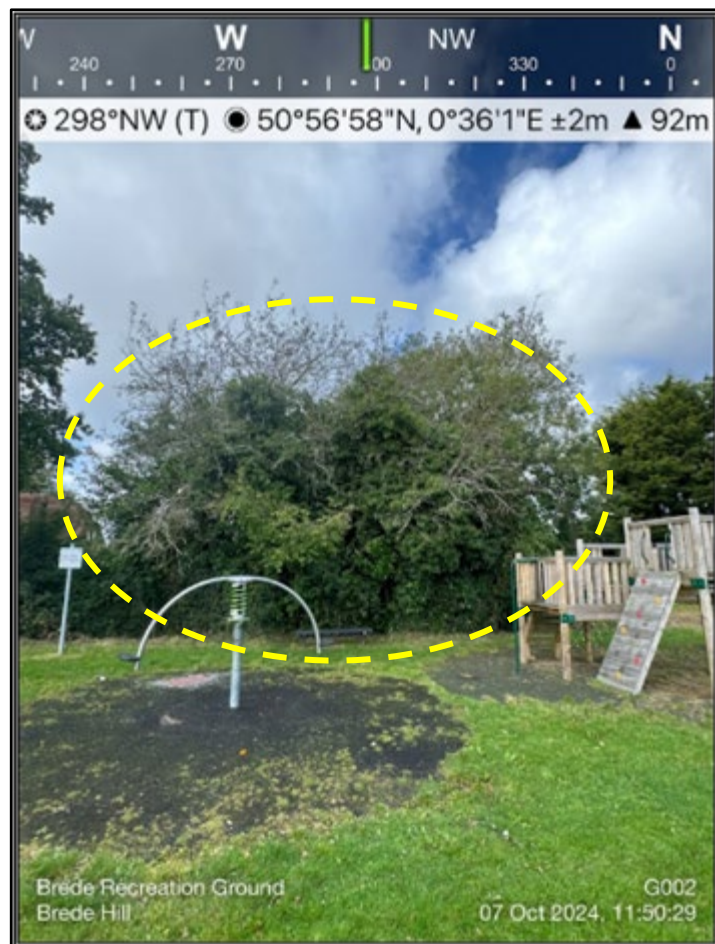
P.15

G002	Hazel (Corylus avellana) Elder x3 'Elder' (Sambucus nigra) Ash x2 (Fraxinus sp.) Crab apple x2 (Malus sylvestris)	Owned by local council. Parkland tree. Tree in hedge. Target # - dwelling. Target # - playground.	Height (m): 9 Crown Radius (m): 5 DBH (cm): N/A Trees: 8 Life Stage: Semi Mature	Group	A group of ivy-clad trees whose crowns overhang the recreation ground and are amongst dense vegetation. Due to the ivy and vegetation, I could not inspect their stems and rooting environment, so I observed their crowns. Several branches are subsiding east over a seat and towards the play equipment. Note: The ivy is extensive and may kill the trees, or its added weight may cause them to collapse partially or totally. Pests and Diseases: Ash Dieback Infection Level 1: 0% to 25%	Not Recorded	Moderate:	07-Oct-2024	1 Year	Risk management: Clear an access route to the trees and the vegetation around their stems. Sever the ivy at the bases and remove a section. The ivy may be hiding possible defects. This will aid future inspections. Crown lift the east-facing branches away from the play equipment. Justification: Tree management. Note: The trees need to be topped, but this can be carried out next year due to the other work. Timescale: 07-Apr-2025 (6 Months)	///shudders.bend.abandon.s

G002 – Mixed species.

It has subsiding branches overhanging the seat.

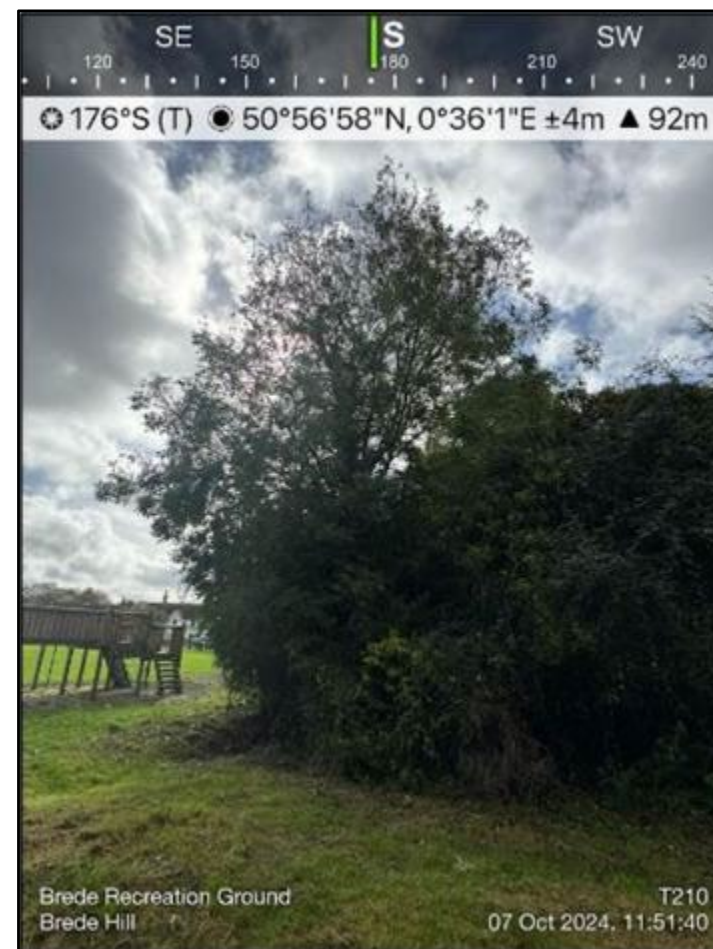
P.16

T210 (not tagged)	Ash (<i>Fraxinus sp.</i>)	Owned by local council. Parkland tree. Tree in fence line. Tree in hedge. Target # - playground. Target # - dwelling.	Height (m): 13 Crown Radius (m): 6 Life Stage: Semi Mature	Tree	Due to a hedge, ivy and dense vegetation, I could not access the tree, so I observed it from the recreation grounds. Pests and Diseases: Ash Dieback Infection Level 1: 0% to 25%	Not Recorded	Moderate:	07-Oct-2024	1 Year	Risk management: Clear an access route to the tree, sever the ivy at the base, and remove a section. The ivy may be hiding possible defects, which will aid future inspections. Monitor for ash dieback when in full leaf. Justification: Management of the tree Timescale: 07-Apr-2025 (6 Months)	///nicknames.beats.poses

T210 – Ash tree amongst dense vegetation

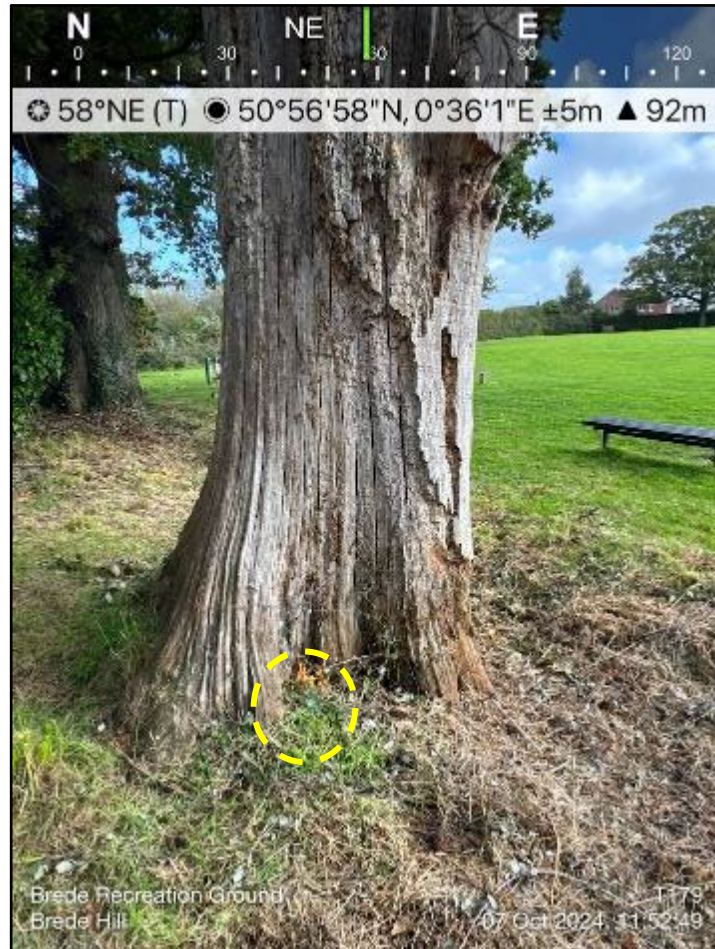
P.17

Ref.	Species	Target Information	Measurements	Structure	Survey Notes	Condition	Risk Category	Inspected	Inspect Period	Recommendations	what3words	Photo	Photo
T179	Not identified (<i>Not identified</i>)	Owned by local council. Parkland tree.	Height (m): 6 Crown Radius (m): 0 DBH (cm): 113 Life Stage: Semi Mature	Tree	It is a monolith. Upon probing, it shows signs of decay and has fungal fruiting bodies on the southeast side in the basal area. The tree plays a crucial role in supporting habitat, biodiversity, and the ecosystem. Fungus: Hypholoma fasciculare (Sulphur turf)	Dead	Moderate:	07-Oct-2024	1 Year	Risk management: Monitor the depth of decay for signs of failing. Justification: Management of the tree. Timescale: 07-Oct-2025 (1 Year)	///ballpoint.ai ms.twisty

T179 – Monolith.

The tree is crucial in supporting habitat, biodiversity, and the ecosystem.
A cluster of active fungal fruiting bodies – Yellow dash highlight

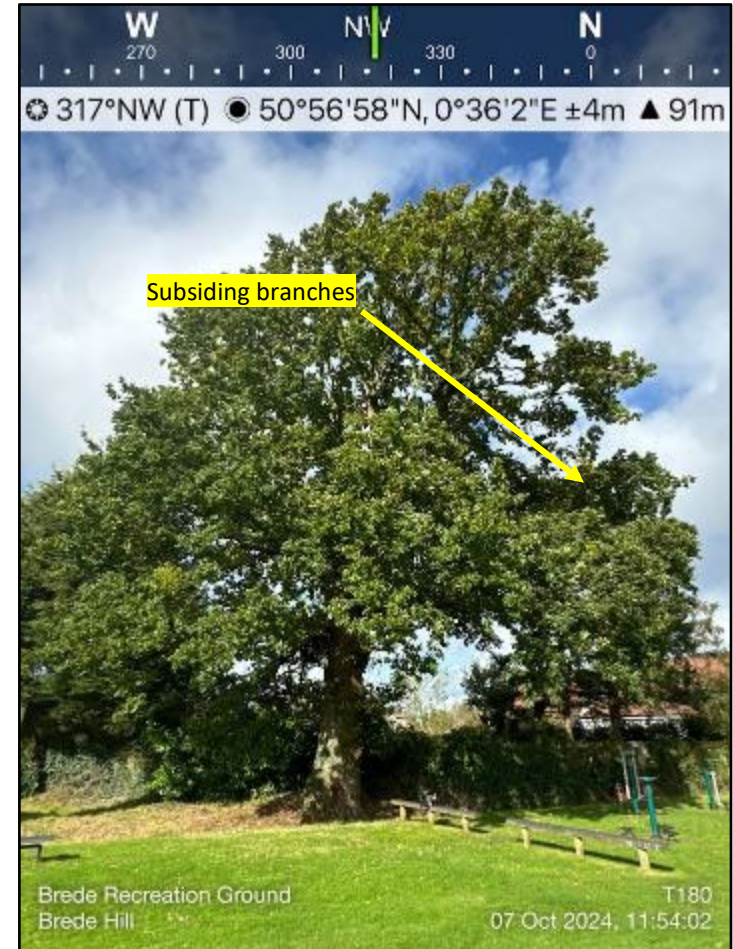
P.18

T180	Pedunculate oak (<i>Quercus robur</i>)	Owned by local council. Parkland tree. Tree in fence line. Target # - dwelling. Target # - playground. Target # - seating Target # - play equipment.	Height (m): 26 Crown Radius (m): 9.5 DBH (cm): 126 Life Stage: Semi Mature	Tree	A large tree with an open crown and subsiding north-facing branches. There is an occluded crack with exudates on one of the north-facing branches. It has apical dieback, epicormic growth, and major, moderate deadwood throughout. The tree was crown reduced approximately 20 years ago and has low branches overhanging the neighbouring garden. Several old fungal fruiting bodies are on the east side (not identified due to their poor condition), where several buttresses sounded hollow when sound tested. On the opposite side (west) is an old fungal fruiting body in the basal region with bark necrosis extending 1m above the fruiting body. The stem has swellings, altered, cracked bark, and is leaning 5° north. There are also two east-facing cavities at 9m and 12m high. I could not fully insert my 77cm probe, with a push, into the fungus sites. I believe the decay is extensive. I observed the crown from the recreation ground.	Fair	High:	07-Oct-2024	1 Year	Risk management: Further investigate the extent of decay with sonic tomography. Justification: This will help manage the tree, determine the extent of the decay, and decide what work is needed. Clearing access around the tree's stem is essential for the sonic tomography equipment. Timescale: 07-Jan-2025 (3 Months)	///coast.entr ust.flashback

T180 – Oak

Subsiding branches increase biomechanical stress loads.

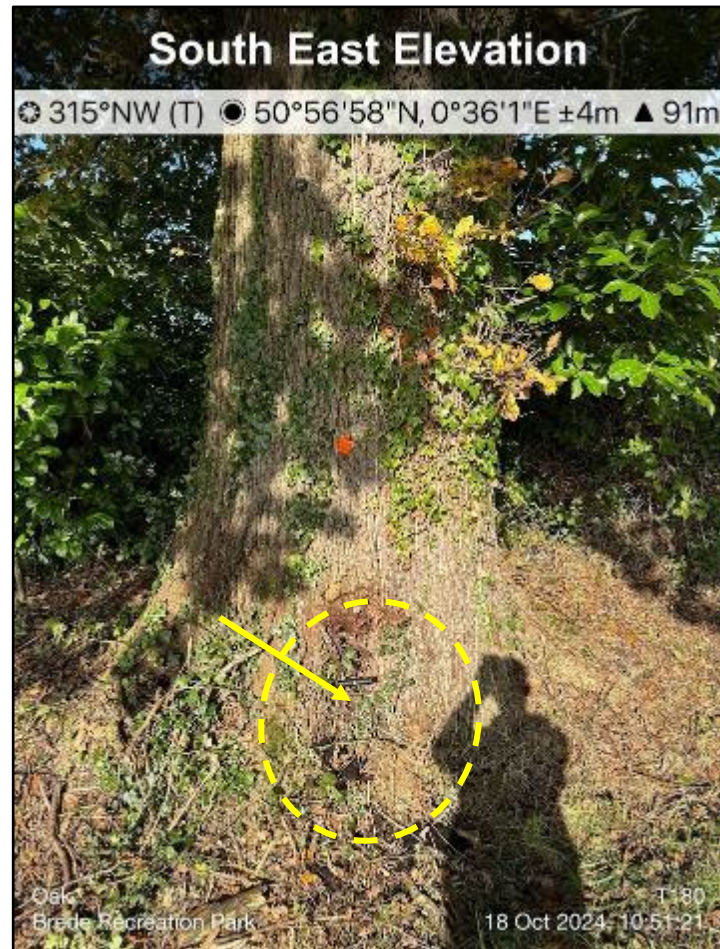
P.19

Clusters of old fungal fruiting bodies – Yellow dash highlight.
The probe can be fully inserted 77cm when pushed.

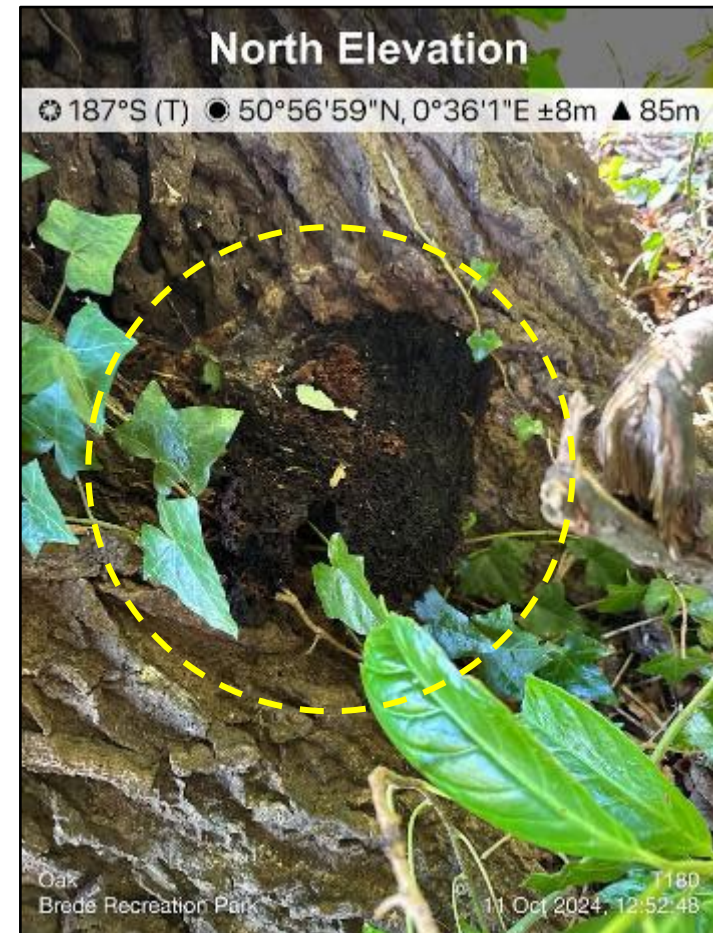
P.20

Another large, old, fungal fruiting body on the opposite side.
Due to the poor condition of the fungus, it was not identified.

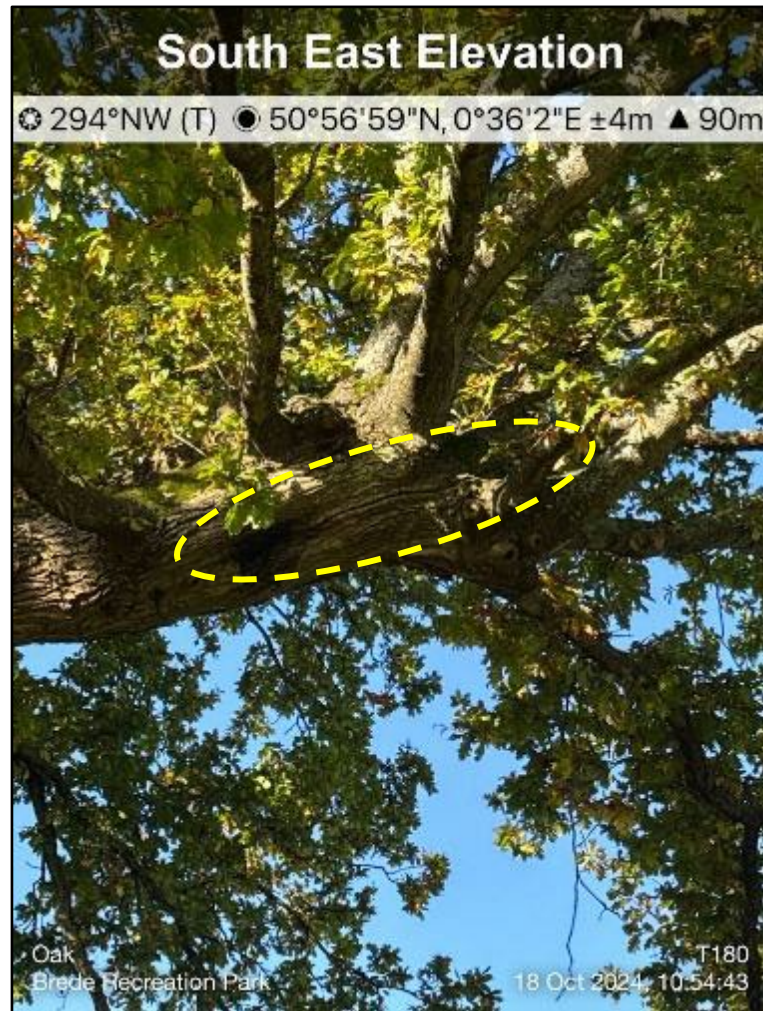
P.21

A crack in a north-facing branch with exudates (yellow dash highlight)

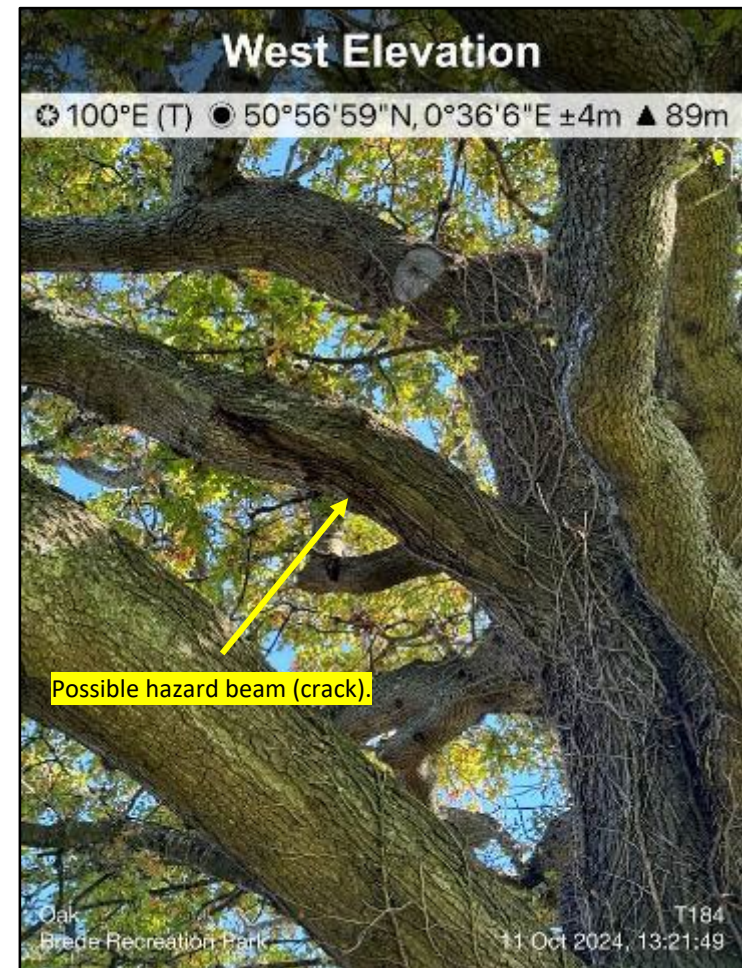
P.22

A north-facing branch is at the centre of the crown.

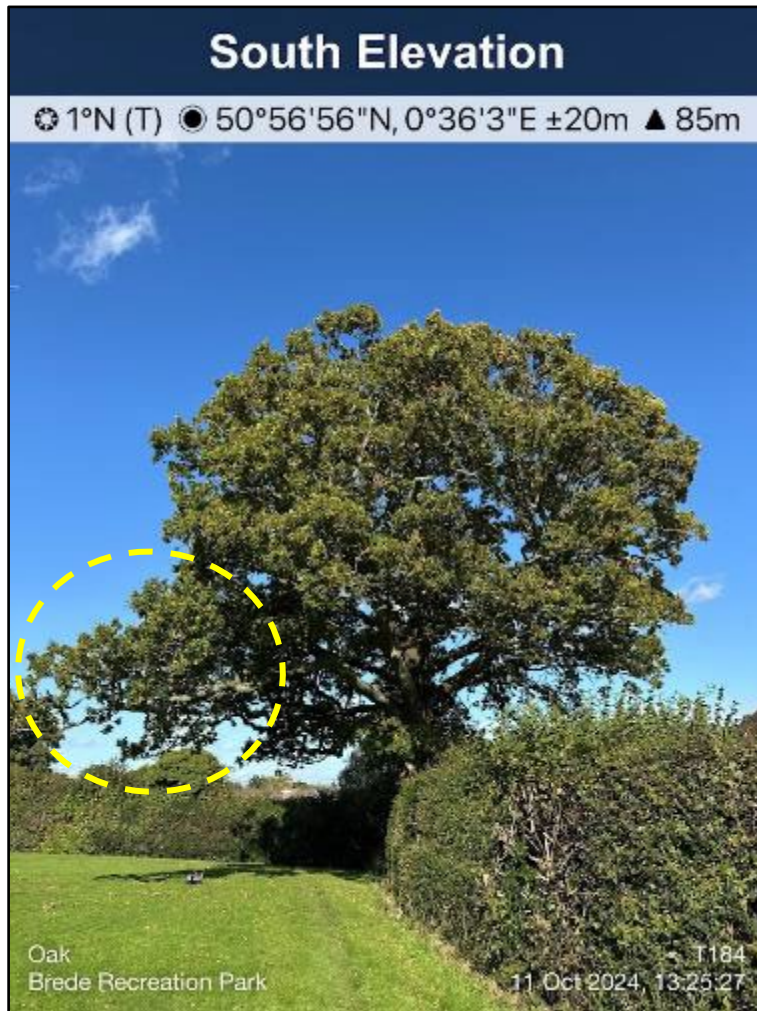
P.23

T184	Pedunculate oak (<i>Quercus robur</i>)	Parkland tree. Tree in fence line. Tree in hedge. Target # - dwelling. Target # - playground.	Height (m): 19 Crown Radius (m): 13 DBH (cm): 108 Life Stage: Mature	Tree	A large tree in a hedge with ivy growing on the lower stem, limiting my inspection to observing the crown from the recreation ground. The tree has lost its central stem at approximately 9m high and has black exudates seeping down it. A north-facing branch is subsiding and has a possible occluded hazard beam on the west side centre stem. Additionally, another sizable southwest branch is subsiding over the recreation park.	Not Recorded	Moderate:	07-Oct-2024	1 Year	Risk management: Clear the hedging and ivy from around the lower stem. Sever any ivy at the base and remove a section. The ivy and hedging may be hiding possible defects. This will aid future inspections. Reduce the southeast and north-facing branches by 3m (end weight reduction) and conduct an aerial inspection of the central stem and the possible hazard beam on the north-facing branch. Report the findings in writing to the inspector. Justification: Management of the tree. Timescale: 07-Apr-2025 (6 Months)	///research.reflected.clubs

Yellow dash highlight - One of the over-extended, subsiding branches
