Lodge Field Playground

Hurst Green Parish Council

Safety Inspection Report

Date of inspection: **27 June 2018**

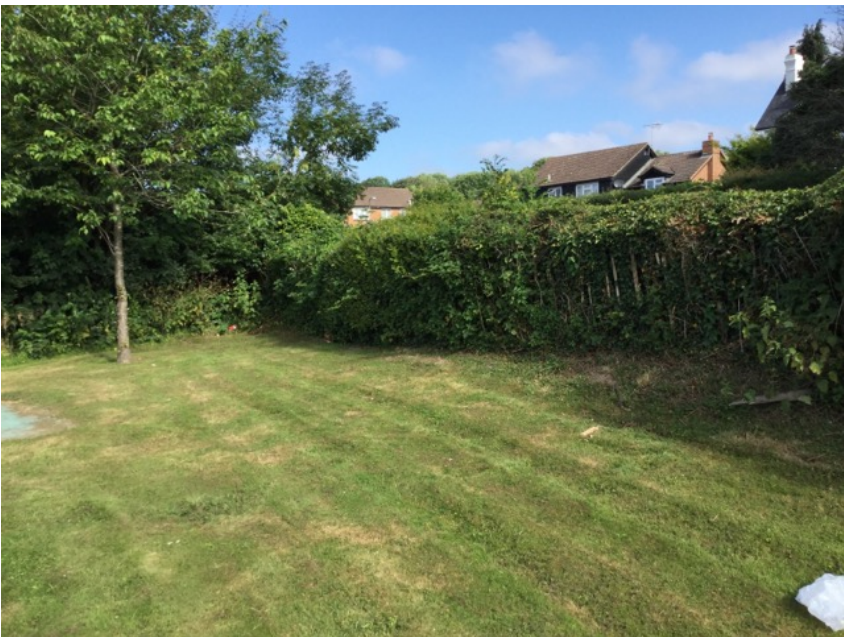
Hedge

Encroaching vegetation or trees.

Nettles and brambles.

Remove.

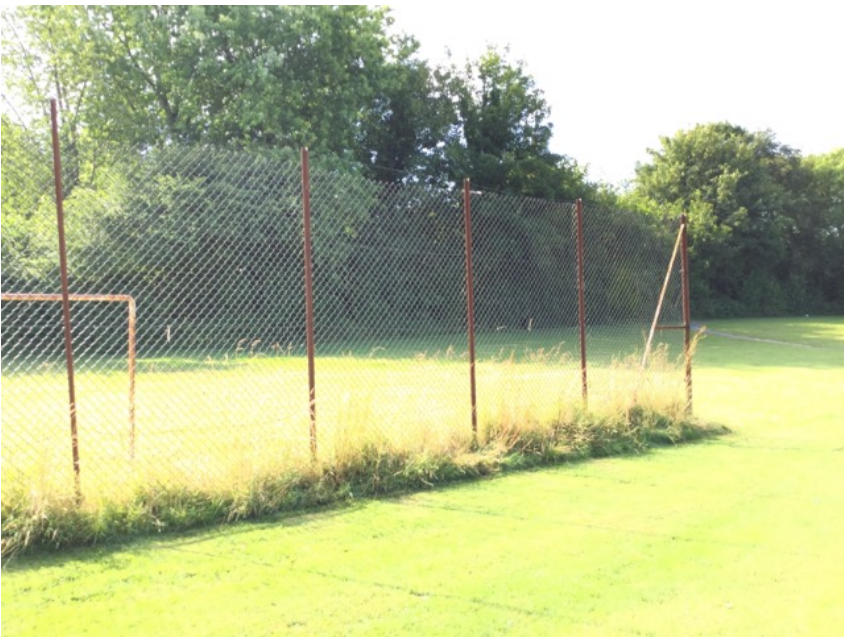
Fencing - Ball Stop

Fixtures loose or missing.

Centre line wire.

Tighten/replace.

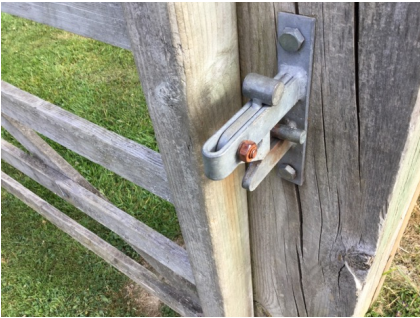
The item is unlocked.

Lock.

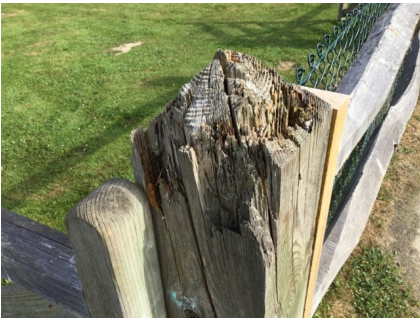
Timber is decayed.

At latch post.

Repair.

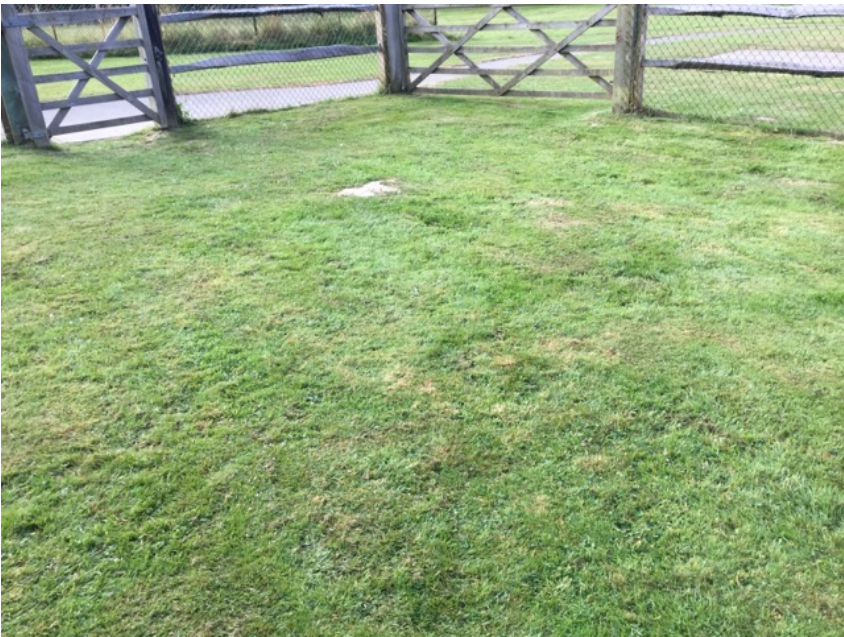
General Surface

Surface is uneven.

Make good.

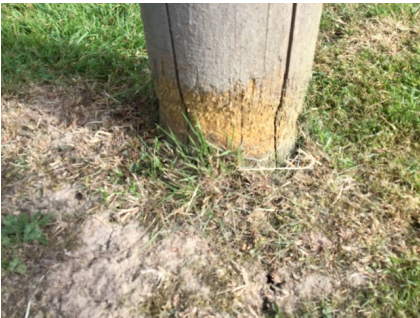
Strimmer damage to supports is likely to accelerate timber rot.

Prevent further damage.

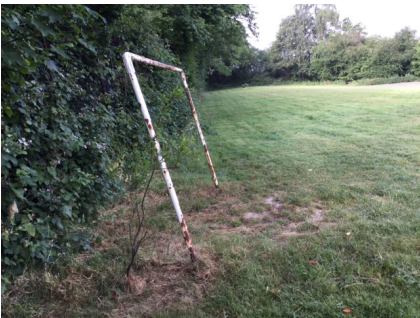
Loose in ground.

It is likely that the goals would fail both the stability and strength tests of EN 16579 if they were applied (not carried out as part of this inspection). We can conduct such testing by separate arrangement.

Reset.

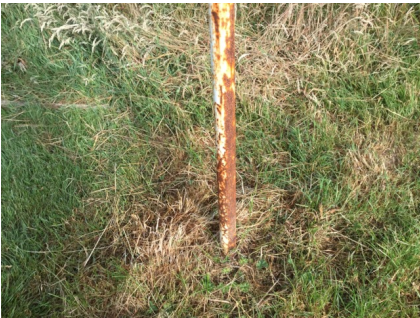
Paintwork is in poor condition.

De-scale back to good base material and coat with lead free paint, using appropriate precautions. Repairs may be necessary where corrosion is severe.

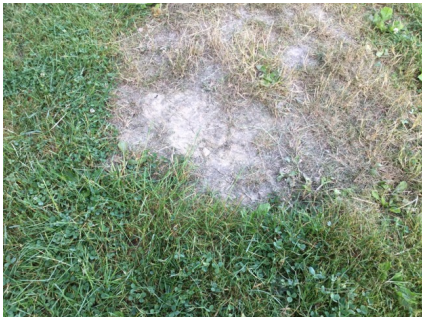
Worn ground areas.

Build up ground levels to remove trip hazard.

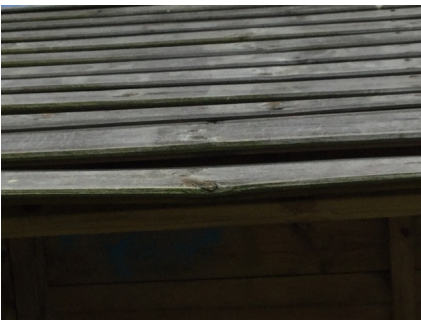
Roof panel is damaged.

Finger trap formed.

Repair.

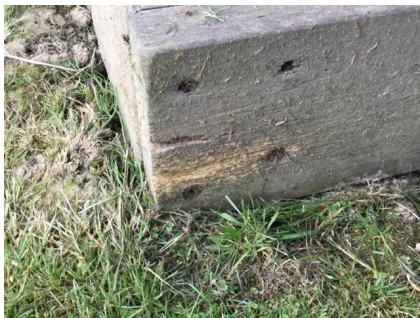
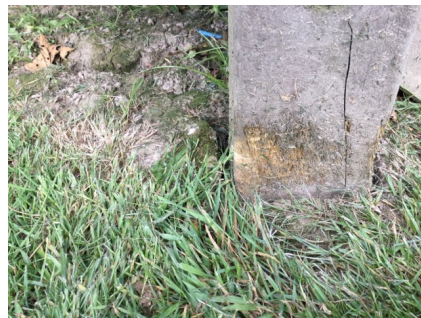
Strimmer damage to supports is likely to accelerate timber rot.

Prevent further damage.

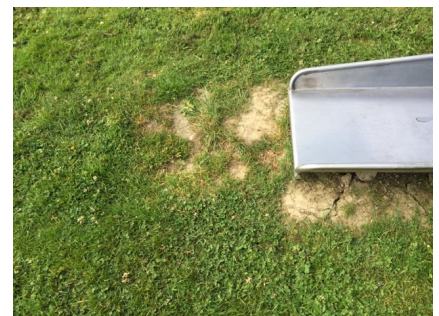
Worn ground areas.

Make good.

Installation of matting wear pads recommended.

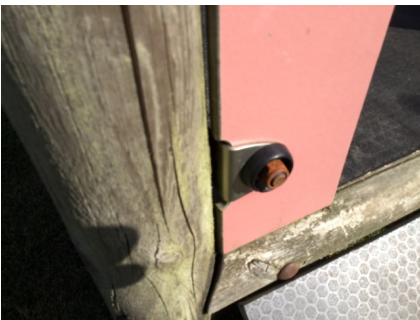
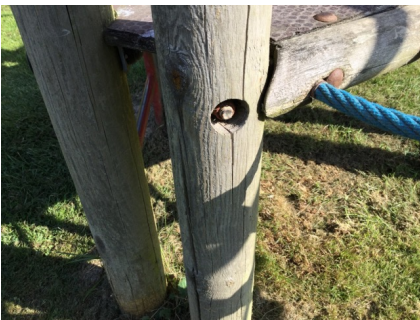
Cap missing.

Across unit.

Replace.

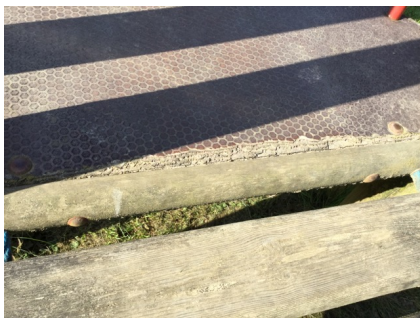
Laminate damaged.

Older deck boards.

Rub down and treat damaged edges.

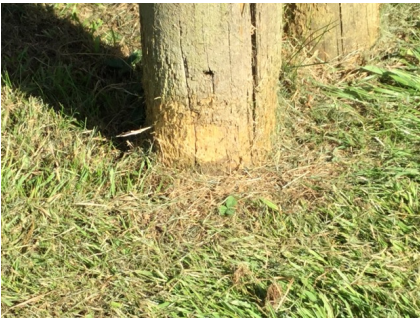
Strimmer damage to supports is likely to accelerate timber rot.

Prevent further damage.

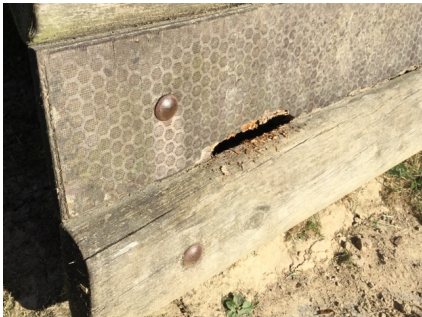
Timber is rotting.

Laminate ramp boards and palisade logs.

Replace.

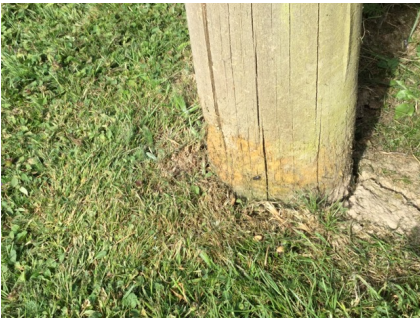
Strimmer damage to supports is likely to accelerate timber rot.

Prevent further damage.

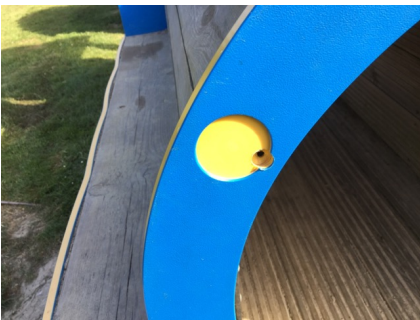
Fixtures loose or missing.

From front panel.

Tighten/replace.

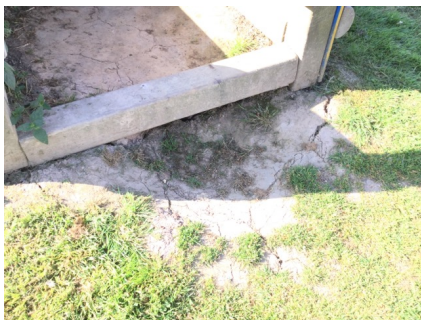
Worn ground areas.

Build up ground levels to remove trip hazard.

Matting wear pad recommended.

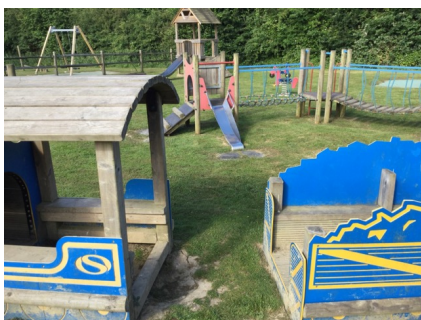
Safety zones should be free from any obstacles.

Coal wagon within 1.5m of accessible roof - Consider increasing space between units.

Read the notes for further action.

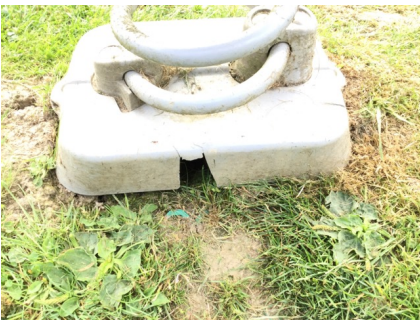
Item is damaged.

Spring base cover (may have been damaged by recent grass maintenance)

Replace.

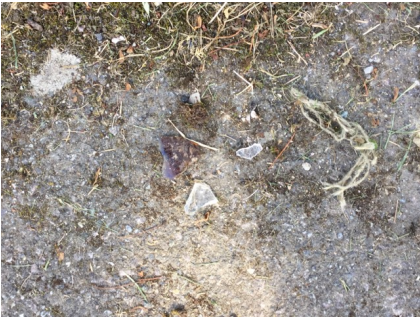
There is broken glass on site.

Clear away immediately.

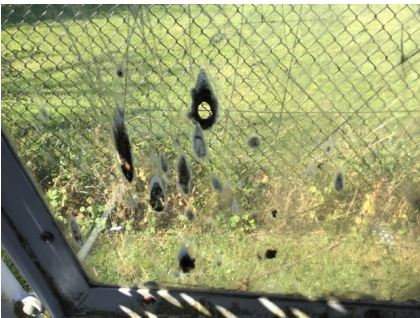
Vandalised (arson).

Glazed window panel.

Repair.

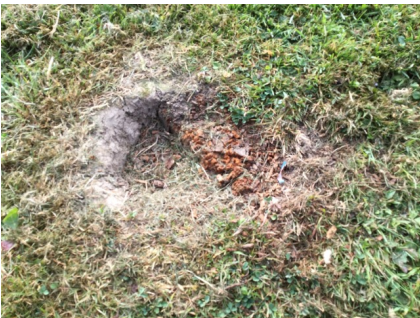
Missing item.

One post missing replace or fill in hole. Trip hazard.

Replace.

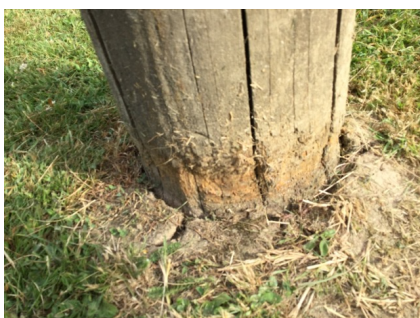
Strimmer damage to supports is likely to accelerate timber rot.

Prevent further damage.

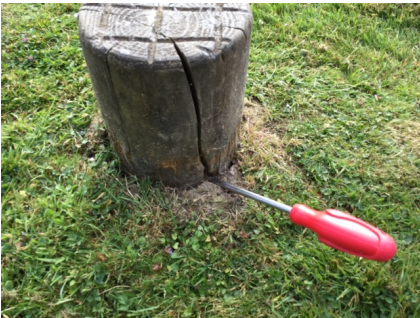
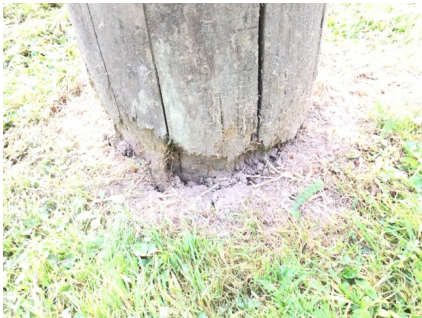
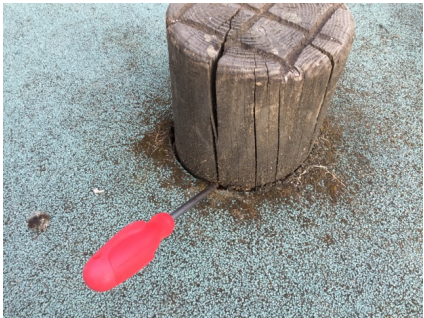
Timber is decayed.

Replace affected parts.

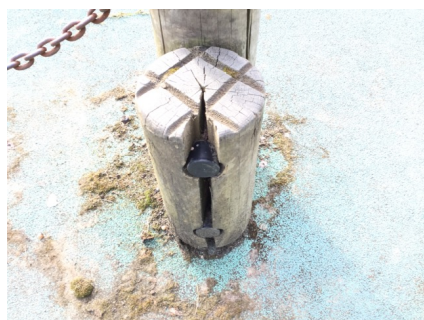
Item is damaged.

Replace.

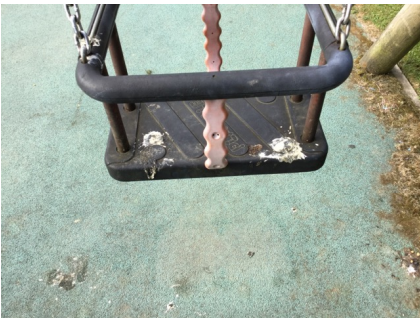
It is recommended that playground equipment be regularly checked for bird fouling - if found, the affected items should be cleaned with a disinfectant solution.

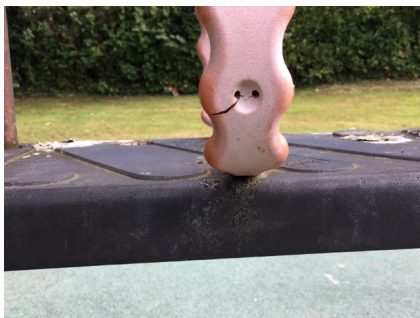
The swing seat has been damaged, but does not require immediate replacement.

Monitor and replace when hard material is exposed.
