**Tree Survey:** Trees at the Recreation Ground and to the east of the church.

**Client:** Brede Parish Council.

Date: November 2023

**DKS-FN/02F**

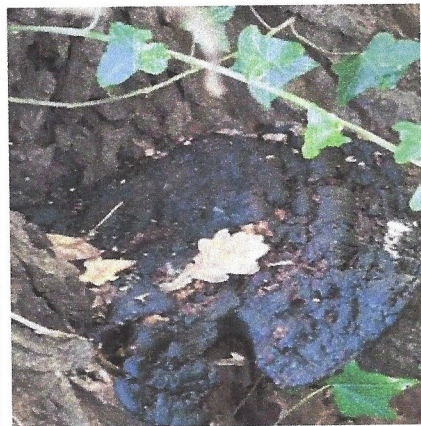
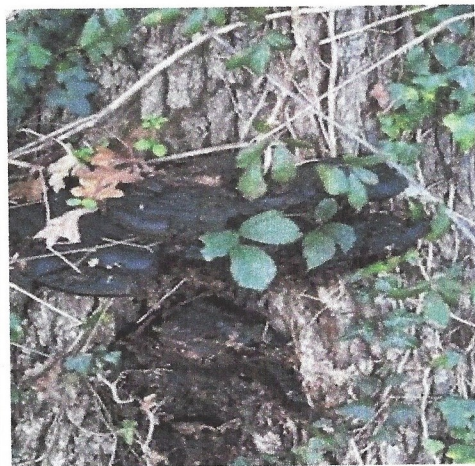
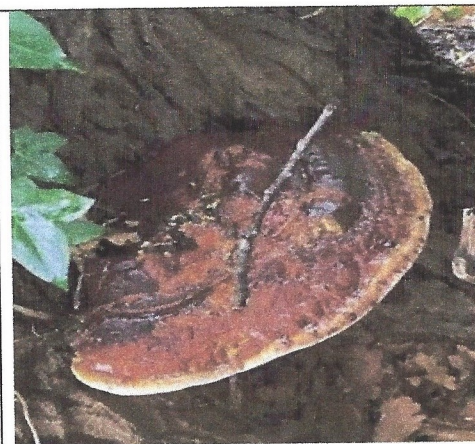
T13	Sessile oaks x 3	M	<p>Row of three Sessile oaks on Northern side of the recreation ground. To the North there is a 2m bank of and then a drop to a pond. No recent signs of root disturbance in the area.</p> <p>Heavy Ivy cover on all three oaks.</p> <p>Oaks one and two are co-dominant. Oak 1. bifurcates at 3 m – union is tight on the Northern stem but sound and sheltered location so unlikely to snap out. Oak 2 splits at 2 m with a tight union. Oak 3. Has a partially failed lateral to the Southern side at 3m – minimal lever arm - no need for action.</p> <p>Chicken wire absorbing into Northern side of Oak 3.</p>	<p>13 m</p> <p>Dbh</p> <p>380 mm 400 mm 500 mm</p>	<p>Monitor annually</p> <p>Important to retain screen to neighbouring pond as a safety deterrent to the pond.</p> <p>2022 – no change. No action necessary. 2023 – no change – no action necessary.</p>
