Client: Parish Clerk: Ms T Dixon
Brede Parish Council

Site Address:
Brede Recreation Ground,
Udimore Road,
East Sussex,
TN31 6DG

Ref: SC/BPC/2/10/2024

TREE ASSESSMENT

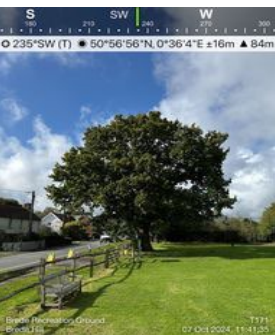
Ref.	Species	Target Information	Measurements	Structure	Survey Notes	Condition	Risk Category	Inspected	Inspect Period	Recommendations	what3words	Photo	Photo
T171	Pedunculate oak (<i>Quercus robur</i>)	Owned by local council. Parkland tree. Roadside tree. Tree in fence line. Target # - footpath. Target # - overhead wires. Target # - playground. Target # - road/stationary traffic. Target # - bus stop	Height (m): 23 Crown Radius (m): 12 DBH (cm): 168 Life Stage: Mature	Tree	The tree has a low crown that overhangs the public footpath and road. There is moderate deadwood throughout the crown, epicormic growth, and a subsiding north-facing branch. On the east side there are several small, deep cavities at ground level with an open crack and decay extending from one cavity up through a union to approximately 6m high, with no wound wood response and remnants of old fungal fruiting bodies inside. There appears to be another crack and dysfunction forming on the south side, with altered bark extending from the union down into the basal area. The stem is fluted with remnants of old fungal fruiting bodies that could not be identified due to their poor condition. I could fully insert my 77cm probe with a push into the cavities in the basal area on the east side of the stem; I believe the decay is extensive. If so, with the weight and size of the crown above, the crack on the east side and what looks like a second crack on the south side increases the likelihood of the tree splitting apart.	Fair	High:	07-Oct-2024	6 Months	Risk management: Further investigate the extent of decay with sonic tomography. Justification: This will help manage the tree, determine the extent of the decay, and decide what work is needed. Clearing access around the tree's stem, including a section of fencing, is essential for the sonic tomography equipment. Timescale: 07-Oct-2024 (Urgent)	///grumble.h atter.earlobes

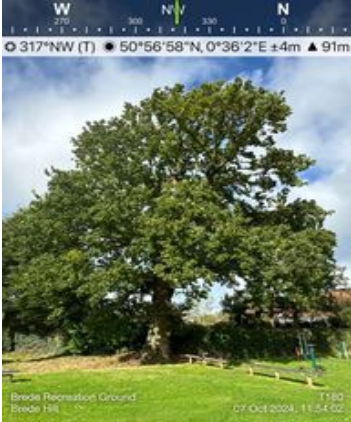
T180	Pedunculate oak (<i>Quercus robur</i>)	Owned by local council. Parkland tree. Tree in fence line. Target # - dwelling. Target # - playground. Target # - seating Target # - play equipment.	Height (m): 26 Crown Radius (m): 9.5 DBH (cm): 126 Life Stage: Semi Mature	Tree	A large tree with an open crown and subsiding north-facing branches. There is an occluded crack with exudates on one of the north-facing branches. It has apical dieback, epicormic growth, and major, moderate deadwood throughout. The tree was crown reduced approximately 20 years ago and has low branches overhanging the neighbouring garden. Several old fungal fruiting bodies are on the east side (not identified due to their poor condition), where several buttresses sounded hollow when sound tested. On the opposite side (west) is an old fungal fruiting body in the basal region with bark necrosis extending 1m above the fruiting body. The stem has swellings, altered, cracked bark, and is leaning 5° north. There are also two east-facing cavities at 9m and 12m high. I could not fully insert my 77cm probe, with a push, into the fungus sites. I believe the decay is extensive. I observed the crown from the recreation ground.	Fair	High:	07-Oct-2024	1 Year	Risk management: Further investigate the extent of decay with sonic tomography. Justification: This will help manage the tree, determine the extent of the decay, and decide what work is needed. Clearing access around the tree's stem is essential for the sonic tomography equipment. Timescale: 07-Jan-2025 (3 Months)	///coast.entr ust.flashback

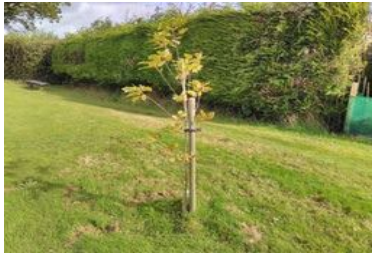
T211	Pedunculate oak (<i>Quercus robur</i>)	Owned by local council. Parkland tree.	Height (m): 2 Crown Radius (m): 0.5 DBH (cm): 10 Life Stage: Young	Tree	A newly planted tree.	Fair	Low:	07-Oct-2024	1 Year	Risk management: Apply a layer of organic mulch that is 50mm to 70mm deep in a 1m radius around the base of the tree, keeping the mulch away from the tree's stem to form a doughnut shape. Remove the tree stakes as soon as the tree can support itself. Keep the spiral wrap around the lower part of the stem to prevent vermin damage. The mulch will also help prevent strimmer damage. Justification: Management of the tree. Note: Mulch has many benefits: It protects the tree, enriches the soil, and helps to retain moisture during dry periods. Timescale: 07-Apr-2025 (6 Months)	///unfilled.changed.stump

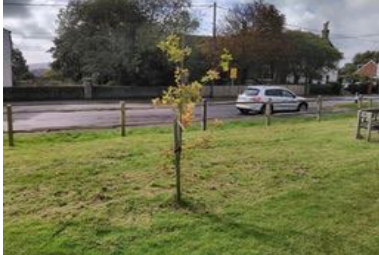
Ref.	Species	Target Information	Measurements	Structure	Survey Notes	Condition	Risk Category	Inspected	Inspect Period	Recommendations	what3words	Photo	Photo
T212	Pedunculate oak (<i>Quercus robur</i>)	Owned by local council. Parkland tree.	Height (m): 2 Crown Radius (m): 0.5 DBH (cm): 10 Life Stage: Newly planted	Tree	A newly planted tree.	Fair	Low:	07-Oct-2024	1 Year	Risk management: Apply a layer of organic mulch that is 50mm to 70mm deep in a 1m radius around the base of the tree, keeping the mulch away from the tree's stem to form a doughnut shape. Remove the tree stakes as soon as the tree can support itself. Keep the spiral wrap around the lower part of the stem to prevent vermin damage. The mulch will also help prevent strimmer damage. Justification: Management of the tree. Note: Mulch has many benefits: It protects the tree, enriches the soil, and helps to retain moisture during dry periods. Timescale: 07-Apr-2025 (6 Months)	///slips.slugs.slings

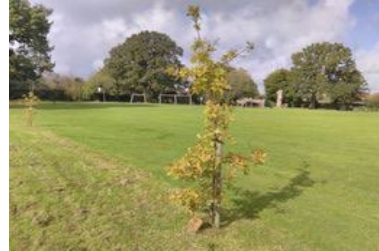
T213	Pedunculate oak (<i>Quercus robur</i>)	Owned by local council. Parkland tree.	Height (m): 2 Crown Radius (m): 1 DBH (cm): 108 Life Stage: Newly planted	Tree	A newly planted tree. The lower stem has been damaged, most likely from a strimmer.	Fair	Low:	07-Oct-2024	1 Year	Risk management: Apply a layer of organic mulch that is 50mm to 70mm deep in a 1m radius around the base of the tree, keeping the mulch away from the tree's stem to form a doughnut shape. Remove the tree stakes as soon as the tree can support itself. Keep the spiral wrap around the lower part of the stem to prevent vermin damage. The mulch will also help prevent further strimmer damage. Justification: Management of the tree. Note: Mulch has many benefits: It protects the tree, enriches the soil, and helps to retain moisture during dry periods. Timescale: 07-Apr-2025 (6 Months)	///village.bu mp.lamppost

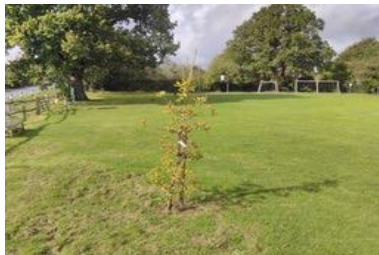
T214	Pedunculate oak (<i>Quercus robur</i>)	Owned by local council. Parkland tree.	Height (m): 2 Crown Radius (m): 1 DBH (cm): 108 Life Stage: Newly planted	Tree	A newly planted tree.	Fair	Low:	07-Oct-2024	1 Year	Risk management: Apply a layer of organic mulch that is 50mm to 70mm deep in a 1m radius around the base of the tree, keeping the mulch away from the tree's stem to form a doughnut shape. Remove the tree stakes as soon as the tree can support itself. Keep the spiral wrap around the lower part of the stem to prevent vermin damage. The mulch will also help prevent strimmer damage. Justification: Management of the tree. Note: Mulch has many benefits: It protects the tree, enriches the soil, and helps to retain moisture during dry periods. Timescale: 07-Apr-2025 (6 Months)	///hothouse. green.poweri ng

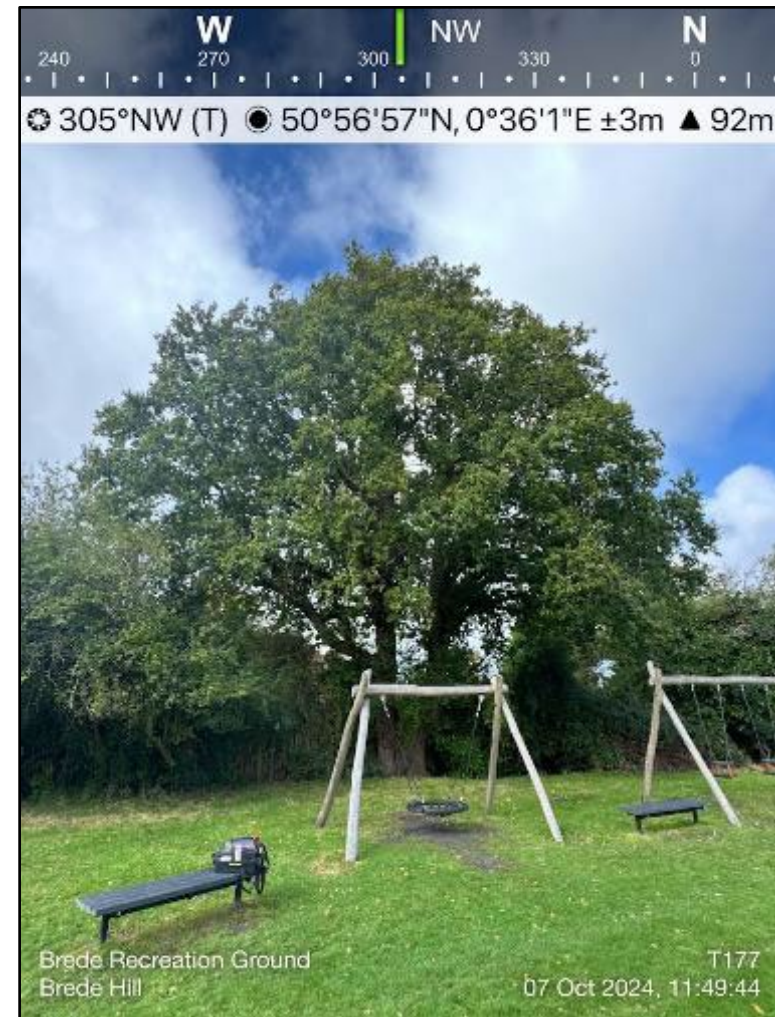
P.12

T177 – A bifurcated oak tree
