Lodge Field Playground

Hurst Green Parish Council

Safety Inspection Report

Date of inspection: **27 June 2018**

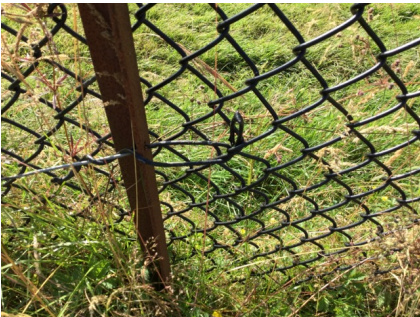
Fixtures loose or missing.

Tighten/replace.

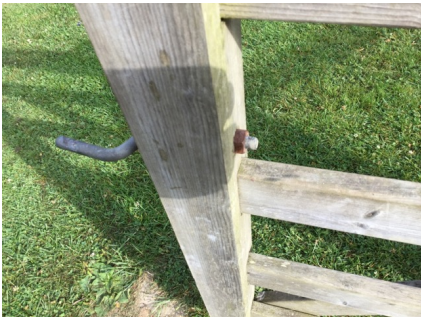
Description
Fixtures loose or missing.
Tasks
Tighten/replace.
Note
Latch pin.

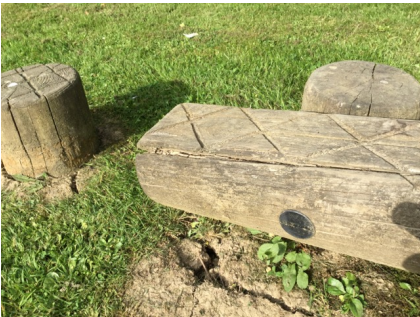
Strimmer damage to supports is likely to accelerate timber rot.

Prevent further damage.

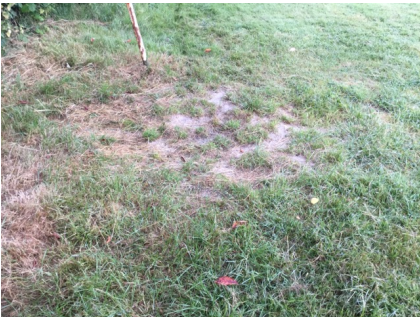
Worn ground areas.

Build up ground levels to remove trip hazard.

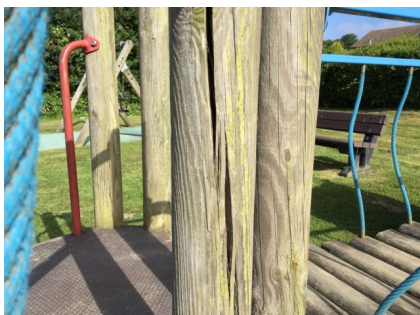
Strimmer damage to supports is likely to accelerate timber rot.

Prevent further damage.

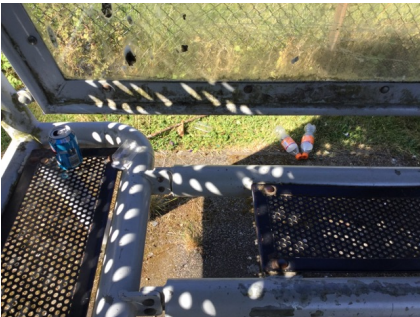
There is broken glass on site.

Repair.

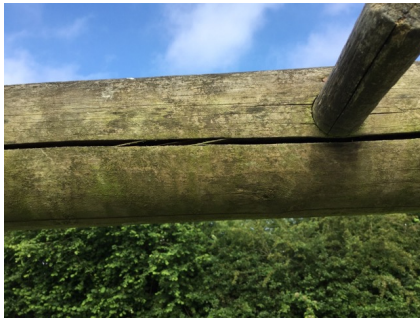
Item is damaged.

Replace.

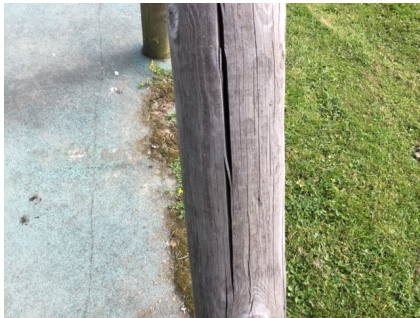
Strimmer damage to supports is likely to accelerate timber rot.

Prevent further damage.

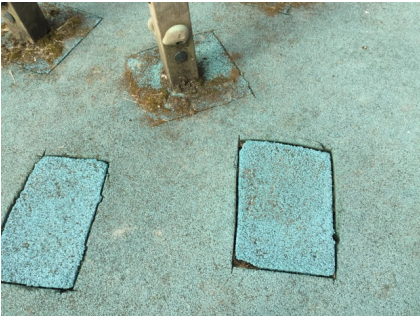
The surface is cracking.

Repair.

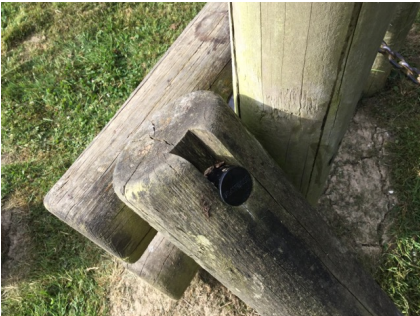
Item is damaged.

Repair.

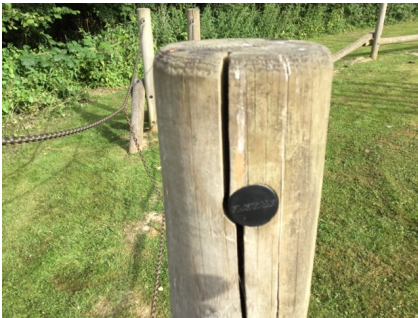
Strimmer damage to supports is likely to accelerate timber rot.

Prevent further damage.
